RANDOLPH CEMETERY
(1872)

PHASE III CONSERVATION REPORT

OCTOBER 7, 2011

COMMITTEE FOR THE RESTORATION AND BEAUTIFICATION OF RANDOLPH CEMETERY

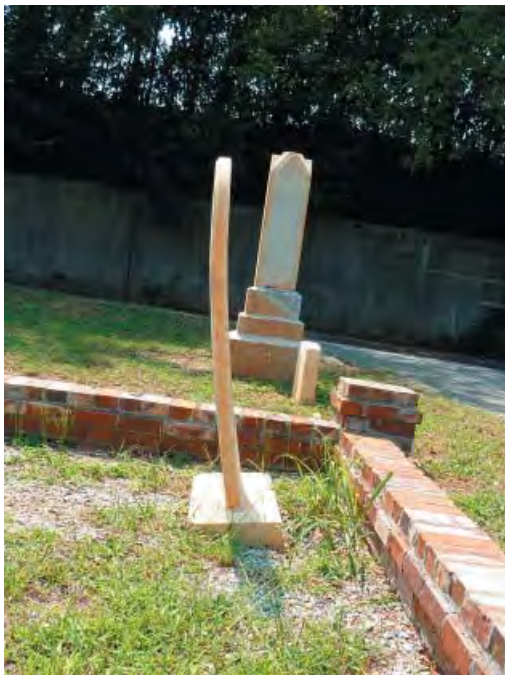
Figure 1: 0001.01, Simon and Ariadna Miller marker, before treatment

The marker for Simon Miller and Ariadna Miller is located in the southwest quadrant of the cemetery, at the side of the looped road. The marker is a roundtop tablet measuring 47-inches in height, 21-inches in width, and 2-inches in depth; the base measures approximately 12-inches in height, 26³/₈-inches in width, and 11⁷/₈-inches in depth. The marker was treated in the first phase of work at the Cemetery during which the broken tablet was repaired and pinned to its base. The broken tablet's time lying on the ground had resulted in bowed marble which exerts pressure on the base. In the year that followed, the ground appears to have shifted slightly and the base settled at an angle leaving it and the tablet un-level and off-balance.

The marker was carefully excavated and laid on a padded surface to relieve pressure on the base and bowed tablet. A foundation of Sakrete Crack Resistant Concrete was poured approximately twice the width and depth of the base and approximately 6-inches deep. Two alloy 316 stainless steel threaded rods, 1/2-inch in diameter and 8-inches long, were embedded in the new foundation. Corresponding holes were drilled into the bottom of the marble base. (Refer to Diagram 1 for pin locations). Once set, the marker was set on its new foundation and pins. It was further secured in place with Premium Pre-Mixed Mortar Mix & Go from Virginia Lime Works.

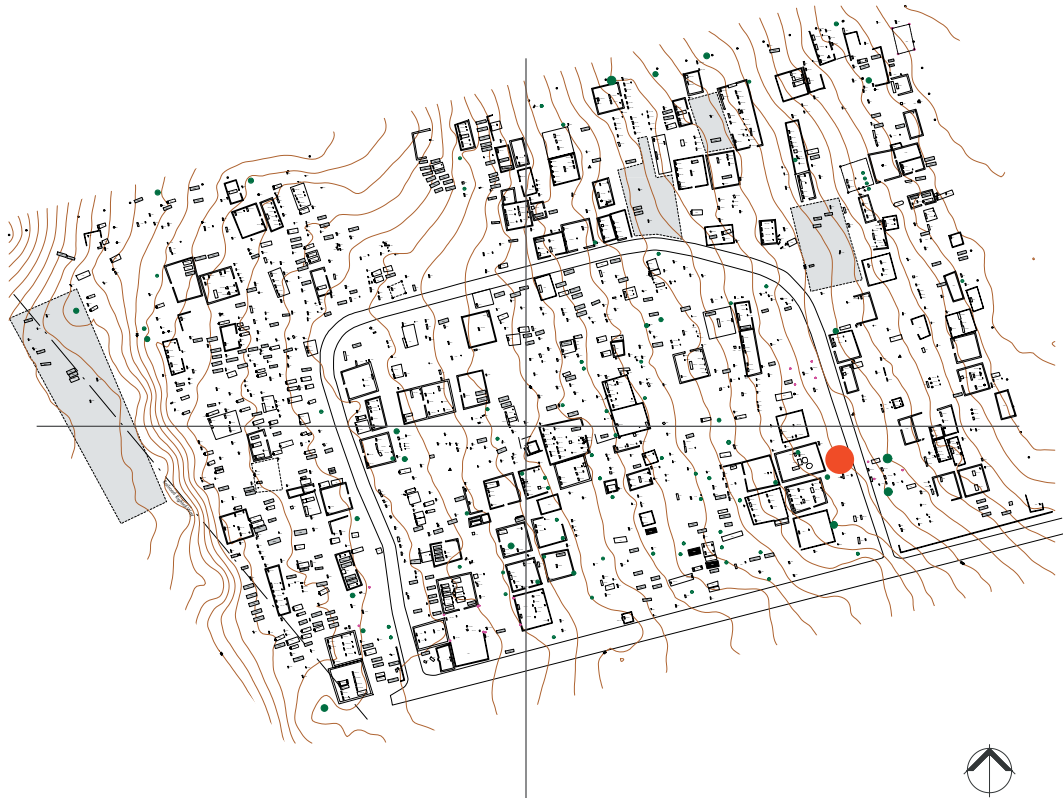
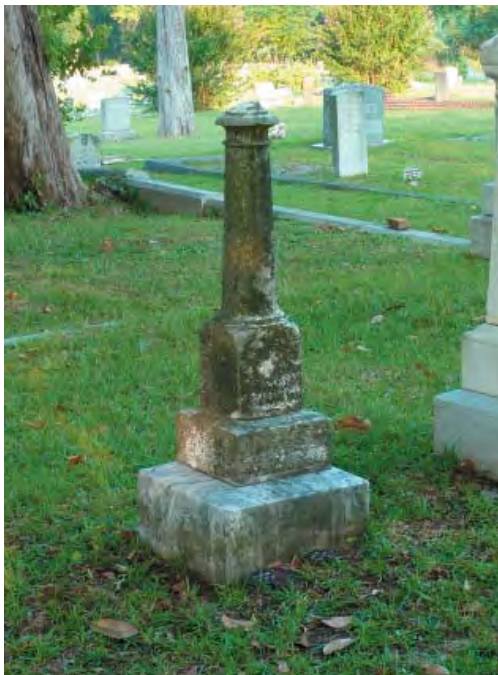
Figure 16: 0490, Anna Hickson marker, before treatment

The marker for Anna Hickson is in the southeast quadrant of the cemetery at the side of the looped road. The marble marker consists of three parts; the base measures 9¾-inches in height, and 18-inches in width and depth; the plinth measures 5½-inches in height, and 12-inches in width and depth, and the pillar measures 31½-inches in height and 8-inches in width and depth. An inscription adorns two sides of the plinth. The marble, presumably an urn, which had topped the pillar had broken off at some point and was missing. The marker was heavily soiled and blackened with biological growth. While the pillar continued to stand on the plinth, it was no longer attached. Three pieces of terra cotta rested against the base of the marker, however it does not appear that these pieces are actually part of the monument.

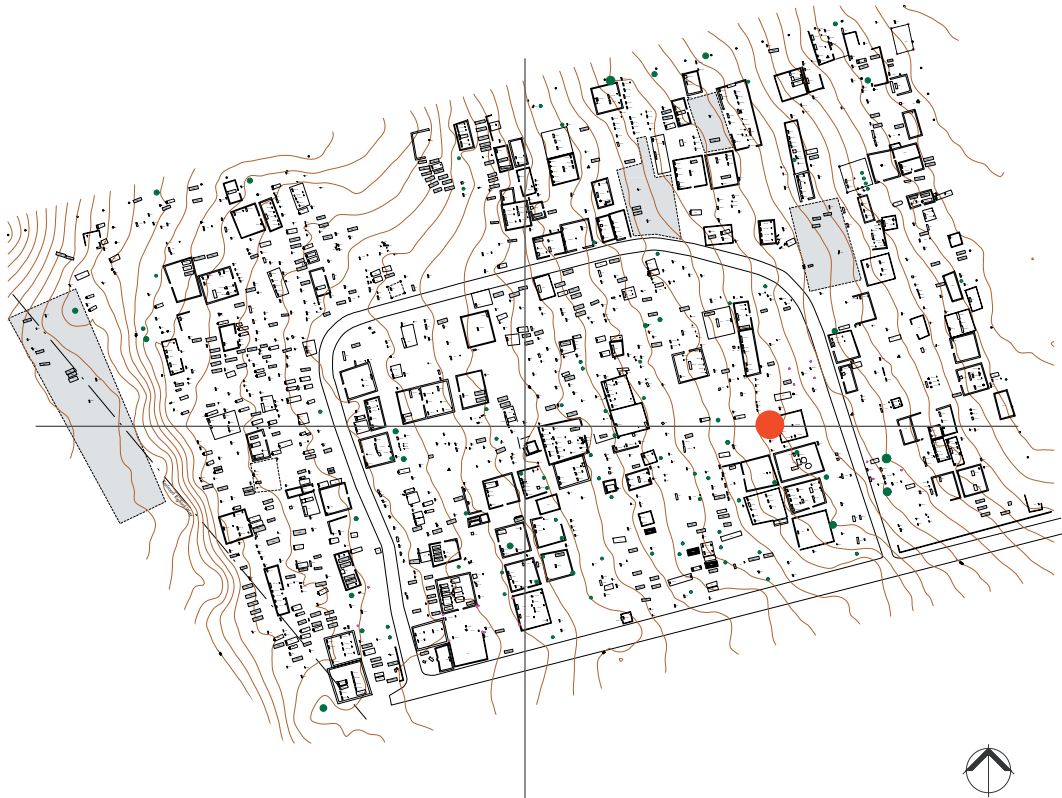
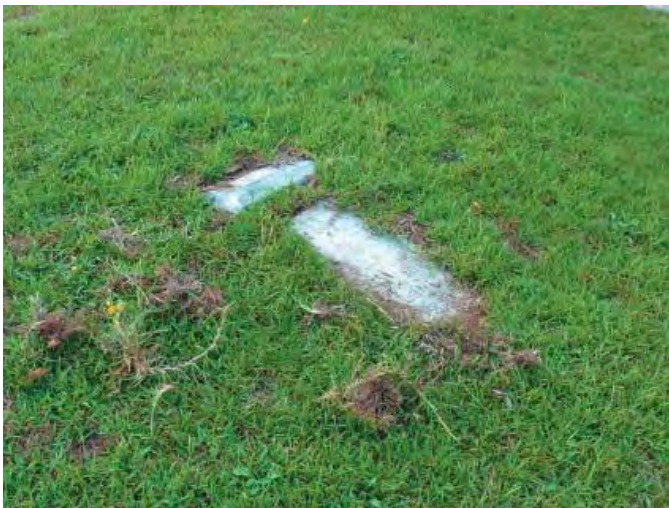
Figure 29: 0501, R.C. Driscoll marker, before treatment

The marker for R. C. Driscoll is located in the northeast quadrant of the cemetery. The marble marker consists of a base and tablet with a round flared top and adorned with scrollwork. The base measures 8-inches in height, 16-inches in width, and 8-inches in depth. The tablet measures 23¾-inches in height, 12-inches in width, and 2-inches in depth. The die in socket type marker had broken with the tablet lying face up on the ground and part of it remaining in the socket of the base. Both the base and tablet were partially buried.

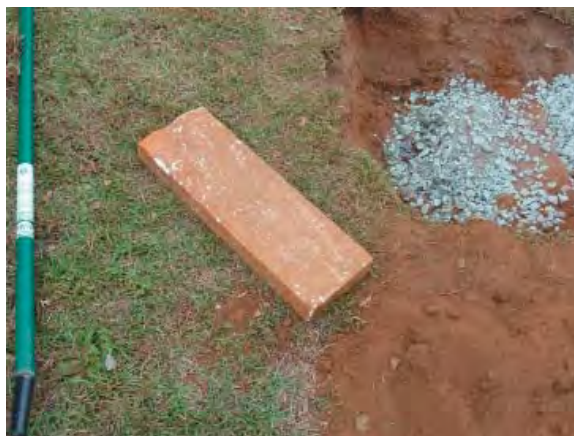
Figure 32: 0501, marble slab

While preparing the area for the new foundation, a small marble slab was discovered. There was no engraving on the marble to indicate that it was a footstone. The marble was photographed and reburied where it had been found.

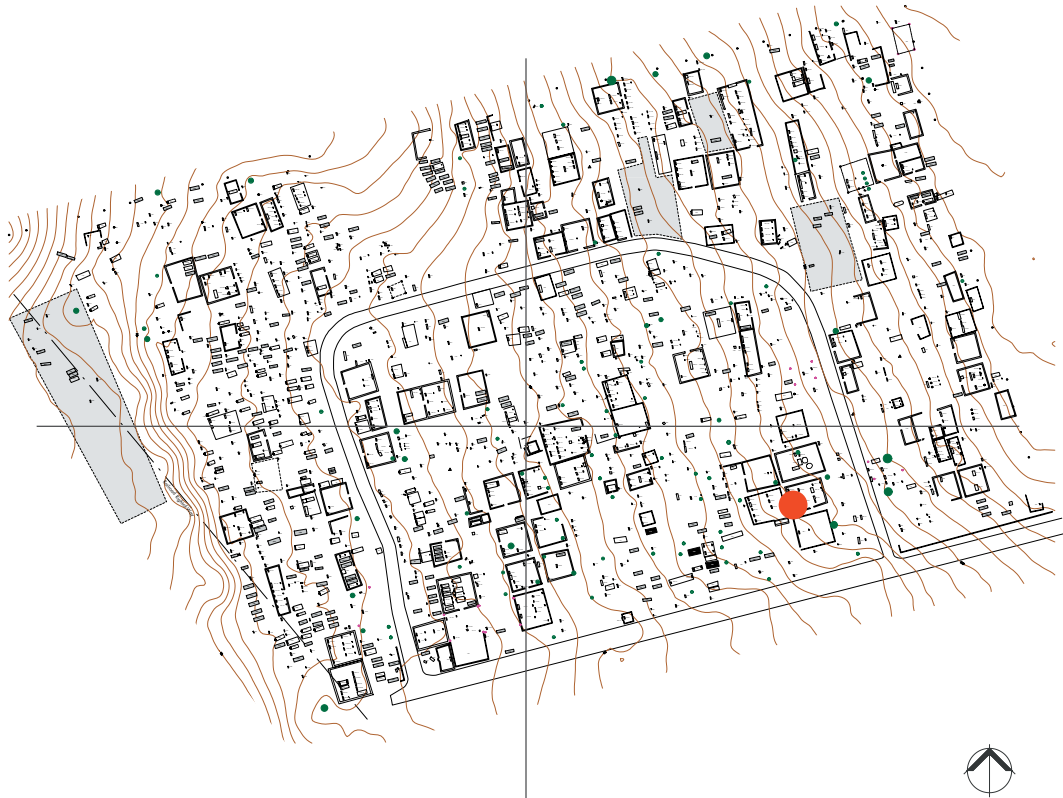
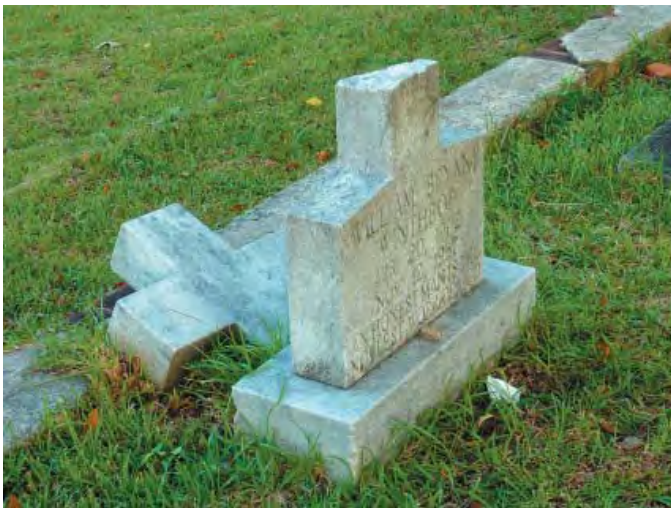
Figure 37: 0505.04, William Bryant Winthrop marker, before treatment

The marker for William Bryant Winthrop is located within a bordered area in the southeast quadrant of the cemetery. The marker is a large grained marble sub-base, base, and cross. The sub-base measures 3½-inches in height, 34-inches in width, and 10-inches in depth, the base measures 8-inches in height, 22-inches in width, and 8-inches in depth. The cross measures 30-inches in height, 16-inches in width (at the arms of the cross), and 3⅝-inches in depth. The base was no longer level. The cross had broken across its middle and the top half lay behind the marker. The bottom half was no longer attached to the base.

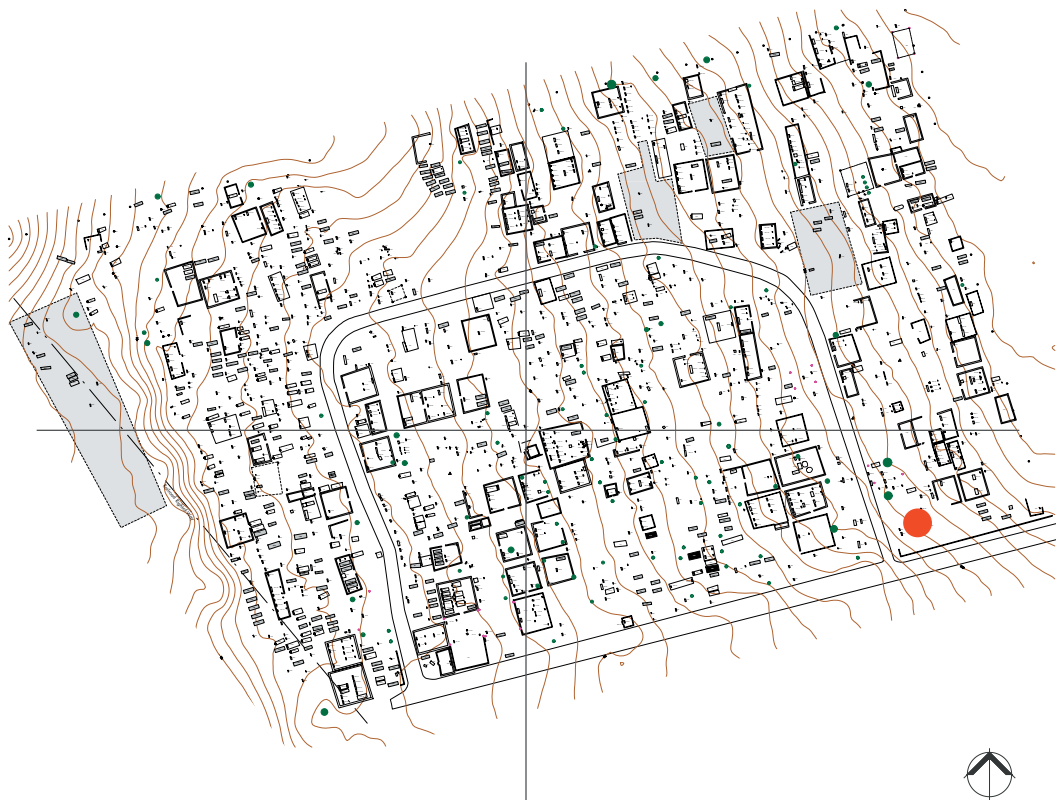
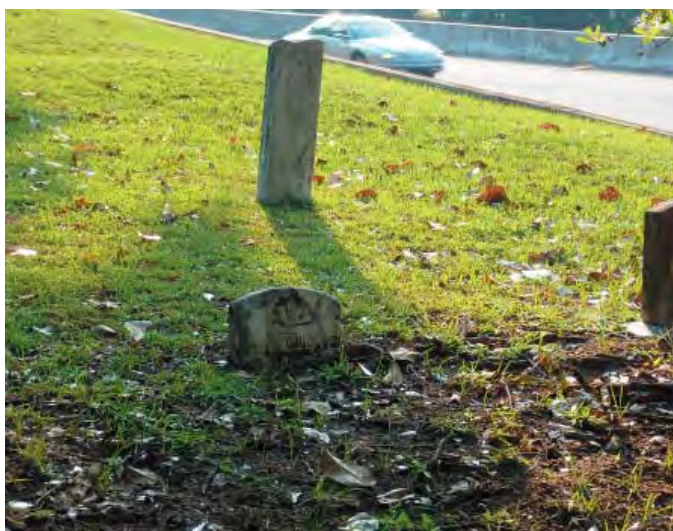
Figure 43: 0509, Millie Goudlock marker, before treatment

The marker for Millie Goudlock is found on the hill in the southeast quadrant of the cemetery. The marble base measures 7 $\frac{1}{8}$ -inches in height, 16 $\frac{1}{8}$ -inches in width, and 8 $\frac{1}{8}$ -inches in depth, the marble roundtop headstone measures 13 $\frac{3}{4}$ -inches in height, 11-inches in width, and 3-inches in depth. A dove adorns the top of the headstone. Movement of the soil downhill had covered the marker within approximately five inches from the top. The visible portion of the marker was soiled and exhibited biological growth.

After the marker was carefully excavated, it was found to still be securely attached to its base. Once free, the marker was cleaned of dirt and biological growth. A solution of water and Vulpex Liquid Soap was prepared using approximately $\frac{1}{2}$ -ounce of soap to 1-gallon of water. The solution was applied to the pre-wet surface and scrubbed using nylon bristle brushes. The surface was then thoroughly rinsed with clean water to remove all traces of the detergent. To address the biological growth, the stone received an additional cleaning using D/2 Biological Solution. The biocide was applied to the dry marble at full strength and agitated using nylon bristle brushes. The solution was scrubbed periodically for approximately 5 minutes before thoroughly rinsing with clean water to remove all traces of the biocide. The marker was reset on approximately 2-inches of level gravel and sand to promote drainage.

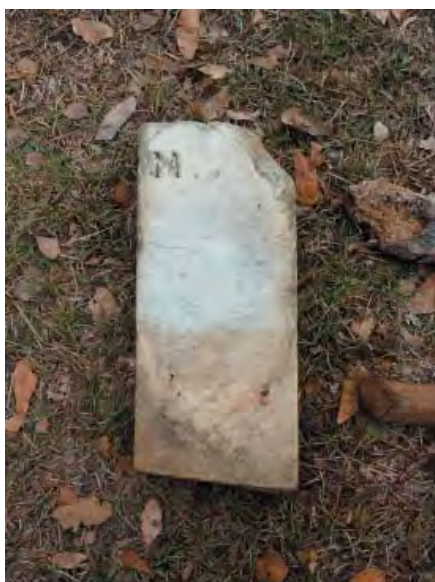
Figure 47: 0509, footstone discovered

When excavating marker 0511, immediately east of 0509, a marble footstone was discovered. The first initial on the footstone was an "M" and while the second initial had partially eroded away, the remaining portion was curved. This indicated the likelihood that it was associated with Millie Goudlock. The marble was cleaned as described above and set immediately uphill from the marker.

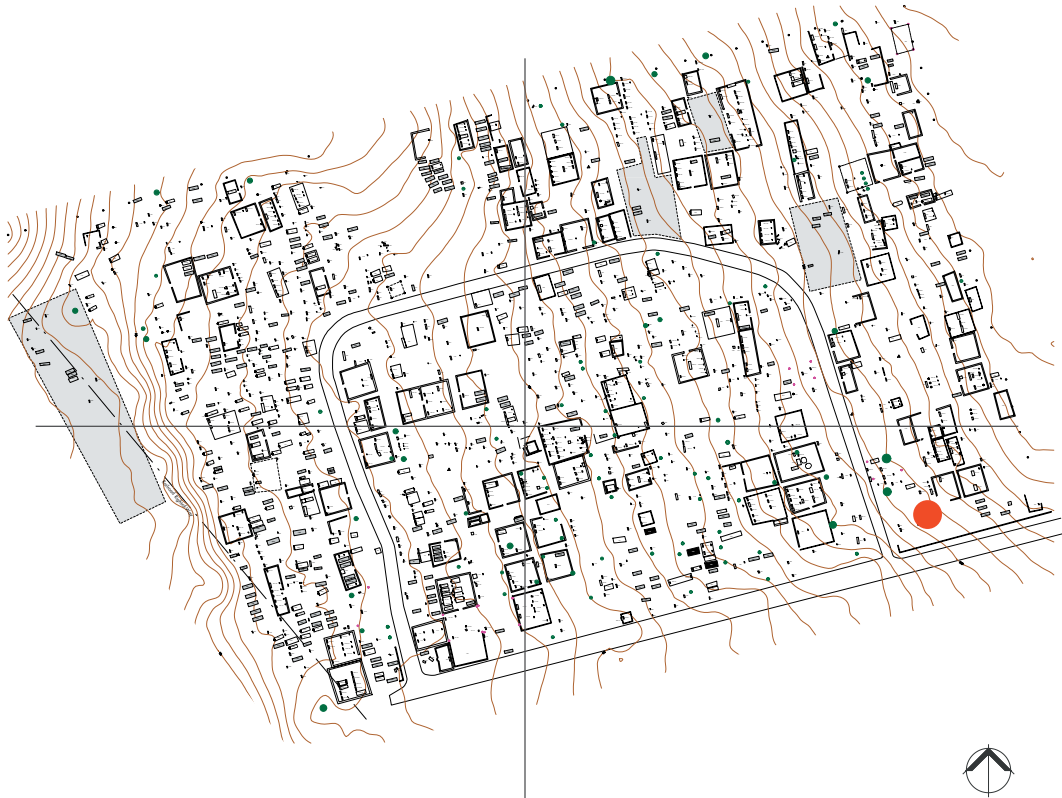
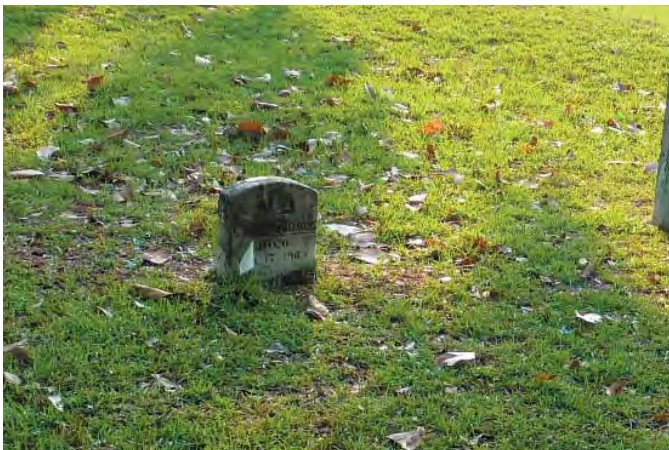
Figure 49: 0511, Lula Woodson marker, before treatment

The marker for Lula Woodson is found on the hill in the southeast quadrant of the cemetery. The marble base measures 7¼-inches in height, 16⅛-inches in width, and 8⅛-inches in depth; the marble roundtop headstone measures 13¾-inches in height, 11-inches in width, and 3⅛-inches in depth. A dove adorns the top of the headstone, above the inscription. Movement of the soil downhill covered the marker within approximately eight inches of the top. The visible portion of the marker was soiled and exhibited biological growth.

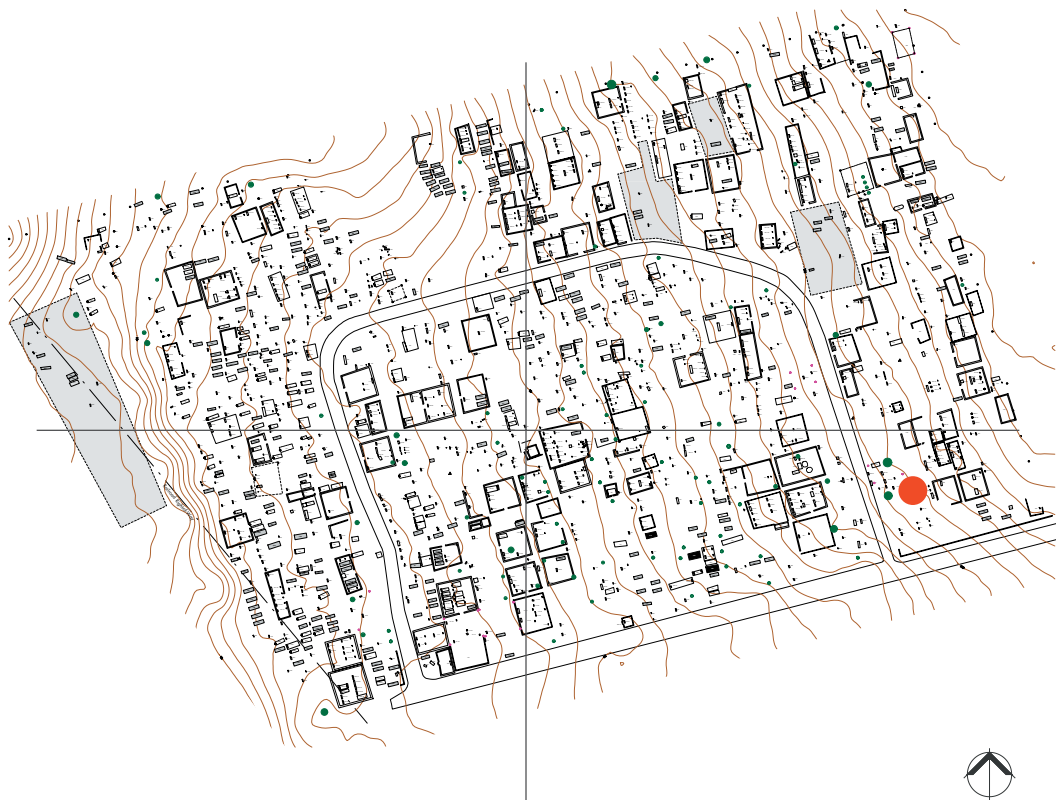
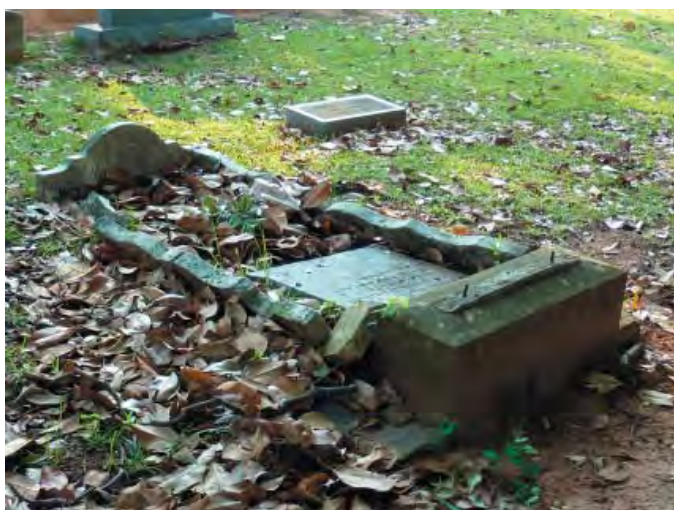
Figure 55: 0514, Unknown marker, before treatment

This unknown marker is located on the hill in the southeast quadrant of the cemetery. It consists of a marble tablet headstone with a beveled edge, a concrete base, a granite sub-base, and marble bedstead. The base measures 8-inches in height, 31³/₄-inches in width, and 10⁵/₈-inches in depth, the base sits askew on the sub-base measuring 4-inches in height, 48-inches in width, and 14¹/₈-inches in depth. The headstone is broken and only the bottom half is visible; this half measures approximately 22-inches in height, 24-inches in width, and 3-inches in depth. The scalloped bedstead is 7¹/₂-inches in height, 26³/₄-inches in width, and 69³/₈-inches in length.

The base and foundation were no longer level and the headstone had broken from it and was lying face up inside the bedstead. The difference in materials, appearance of mortar along its broken edge, and pinholes existing at the top of the broken tablet indicate that the marker had been previously repaired. Ferrous pins remain in the base, headstone, and bedstead. The scalloped bedstead was broken in multiple locations and stood haphazardly along the ground. All elements were soiled and exhibited heavy biological growth.

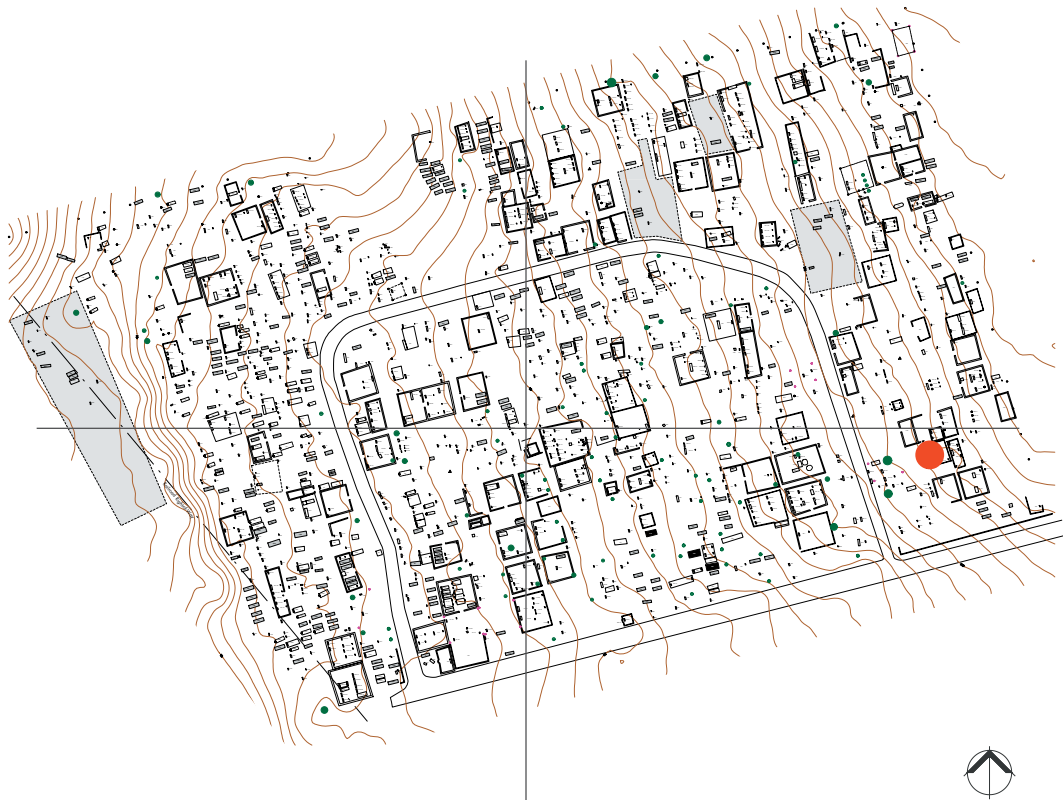
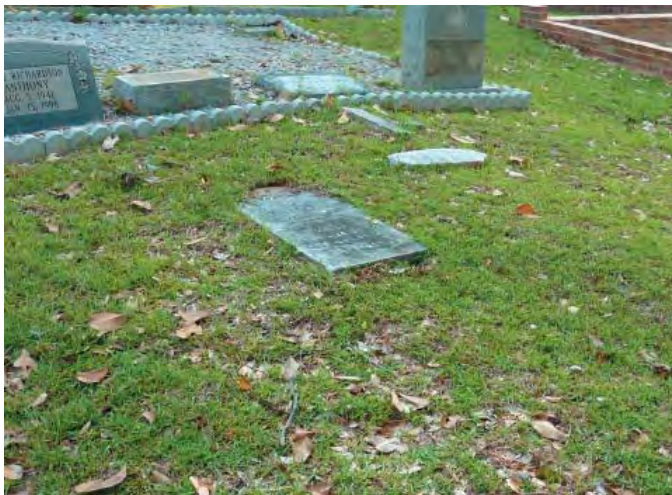
Figure 65: 0537, Wyatt McMaster and Rachel Rhoda Jackson marker, before treatment

The tablet had fallen backward and was lying face up on the ground. At the time of the survey the base and sub-base were not visible. The marble footstone reading “W. M^c. M” was found lying beside the tablet.

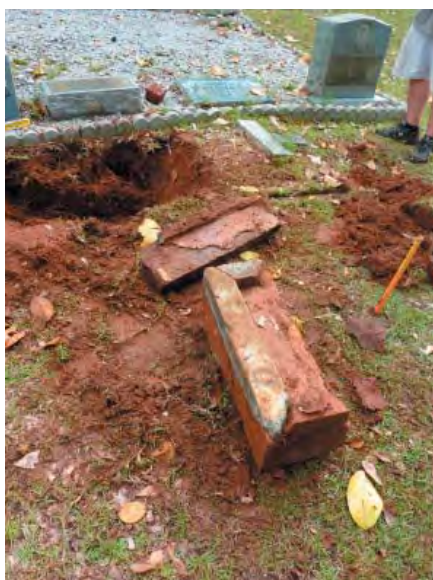
Figure 68: 0537, excavated sub-base and base

The tablet was lifted from the ground and the area was prepared for the installation of a new base at which point the original, though broken, base and sub-base were discovered. All marble pieces were cleaned. A solution of water and Vulpex Liquid Soap was prepared using approximately ½-ounce of soap to 1-gallon of water. The solution was applied to the pre-wet surfaces and scrubbed using nylon bristle brushes. The surfaces were then thoroughly rinsed with clean water to remove all traces of the detergent. To address biological growth, the elements received an additional cleaning using D/2 Biological Solution. The biocide was applied to the dry marble at full strength and agitated using nylon bristle brushes. The solution was scrubbed periodically for approximately 5 minutes before thoroughly rinsing with clean water to remove all traces of the biocide.

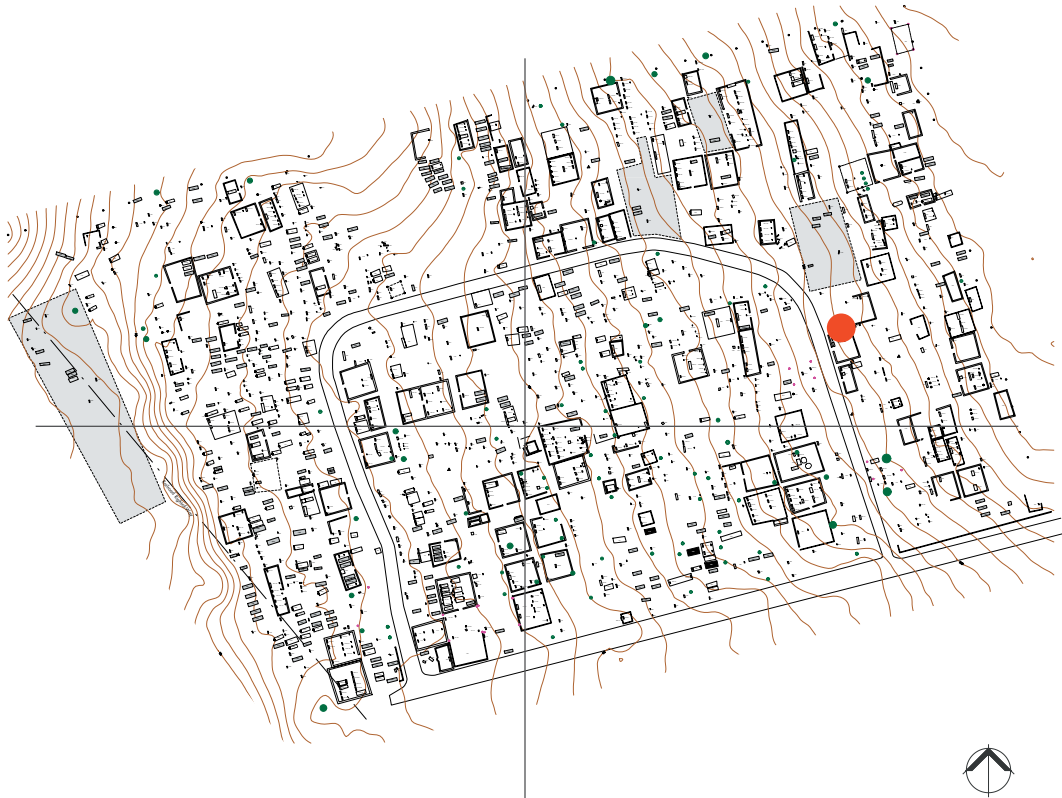
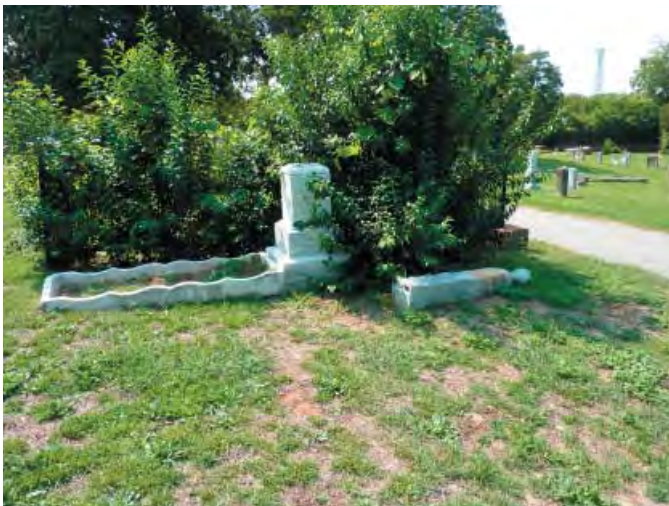
Figure 73: 0558, Sarah H. Smith marker, before treatment

The marker was repaired during the first phase of work at the Cemetery. Within the following year, it appears that the marker was knocked, possibly by a riding mower, and the pillar fell off. The threaded rod remains secure in the plinth and no damage occurred to the bottom of the pillar. The repaired area at the urn was damaged, though the urn was still attached.

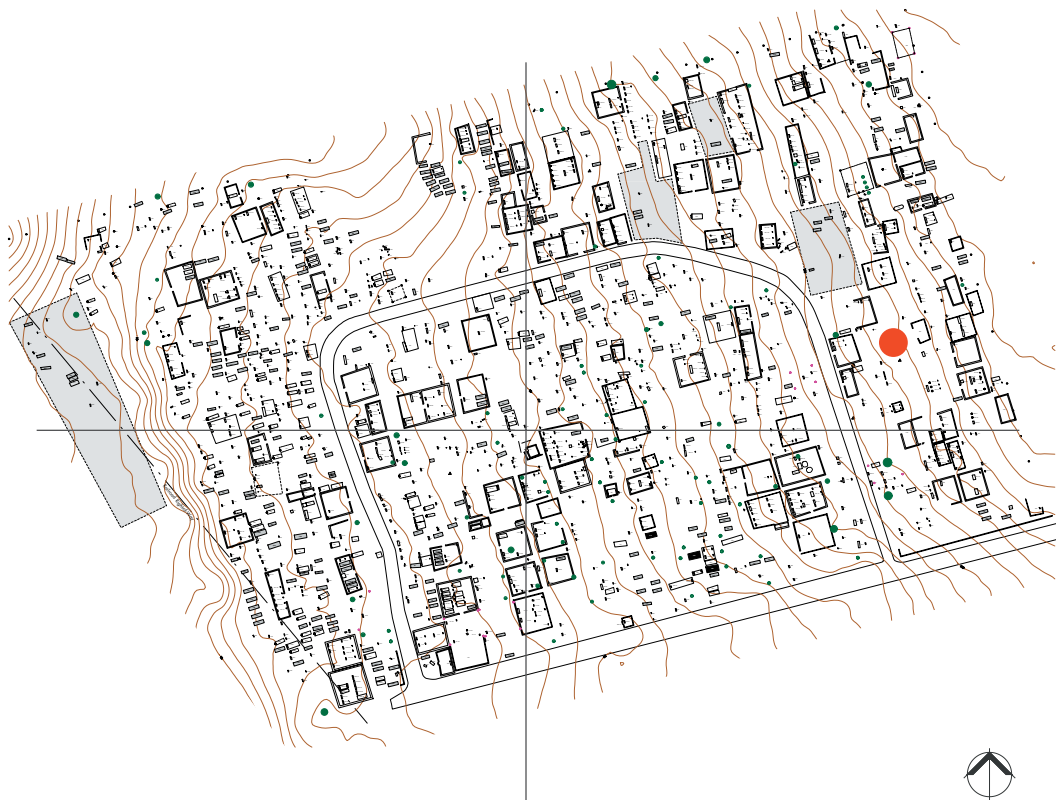
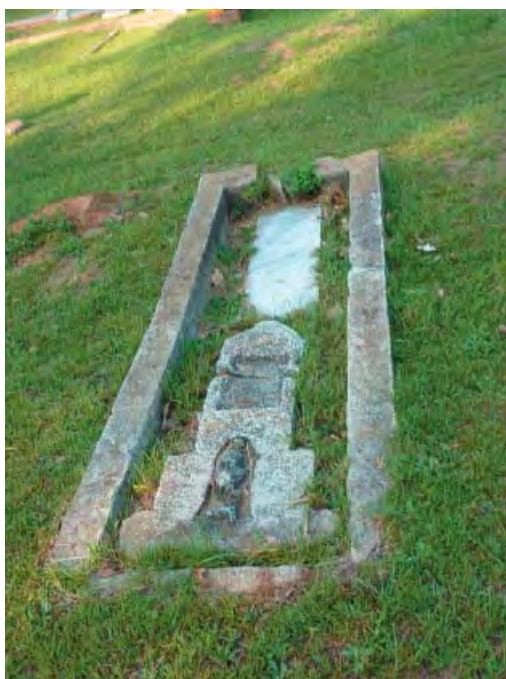
Figure 79: 0565, Robert Eugene Brown marker, before treatment

The marker for Robert Eugene Brown is located in the northeast quadrant of the cemetery. It consists of a concrete headstone, a marble headstone, and a concrete bedstead. The concrete headstone has a stepped gable and measures 45-inches in height, 24-inches in width, and 5-inches in depth. A figure is centered in a small niche in the lower half of the headstone above which is a rectangular niche. The rectangular niche is now empty though it may have at one time held a small tablet with an inscription. The concrete headstone was lying on its backside in east end of the bedstead and was broken across the upper niche. The marble headstone is a roundtop military marker measuring 42-inches in height, 13-inches in width, and 2½-inches in depth. The headstone was lying facedown in west end the bedstead. The concrete bedstead is broken across the middle on its long sides and a thinner wall on the west end had been broken into multiple pieces.

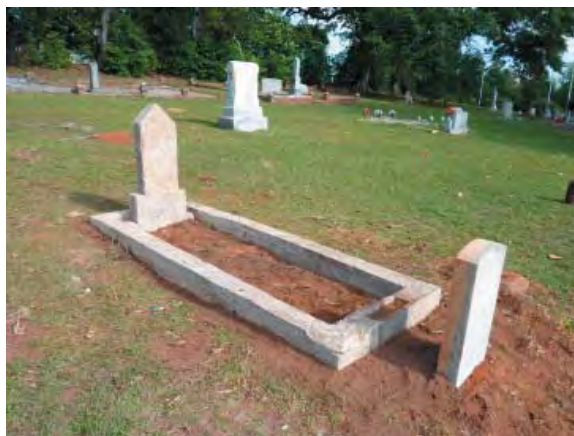
Figure 88: 0565, after treatment

The concrete marker was repaired by pinning the halves together. The conservator drilled holes midway on the vertical break. Two alloy 316 stainless steel threaded rods, ⅜-inch in diameter and 6-inches in length, were used to connect the holes across the breaks. The pins were secured into the holes using SikaDur® 31 Epoxy. Additionally, the conservator spread a thin layer of the epoxy on the broken faces of the marble. (Refer to Diagram 14 for pin locations).

The bedstead pieces were set onto a bed of Quikrete Crack Resistant Concrete and leveled. The broken thin west end walls were pieced back together and epoxied using SikaDur® 31 Epoxy.

The concrete foundation was extended inside the bedstead on the east end to accommodate the concrete headstone. This headstone was set on a bed of Premium Pre-Mixed Mortar Mix & Go from Virginia Lime Works. Once reinstalled, all of the cracked or broken areas of the concrete were filled with Jahn Concrete Repair Mortar to prevent water infiltration and create a more cohesive surface appearance. The areas to be patched were moistened with clean water, at which point Jahn M90 S1-CR was applied. The Repair Mortar was further tinted using dry pigments and potassium silicate to blend with the surrounding concrete. Microcracks within the concrete headstone were address by grouting to limit water infiltration. After wetting the cracks, the grout, Jahn Masonry Repair M30 Micro Injection Grout, was inserted into the voids using a syringe.

The location of the marble headstone and broken thin west end walls upon the survey indicated that the military headstone had been located just outside the bedstead. It was reinstalled at this location on a bed of approximately 2-inches of gravel and sand to promote drainage.

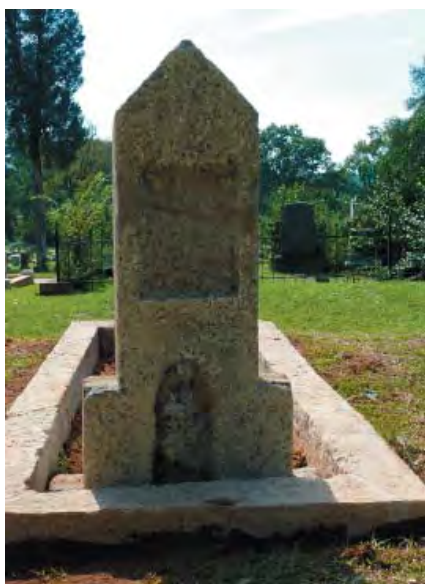
Figure 89: 0565, after treatment

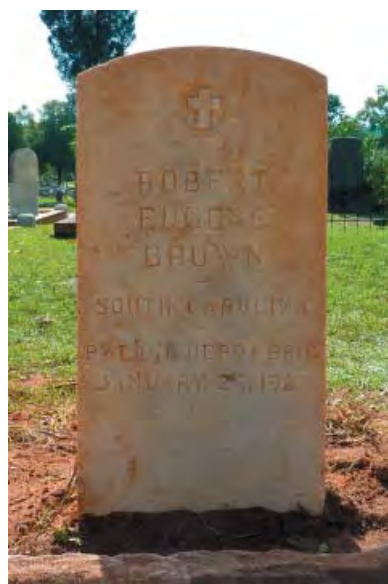
Figure 90: 0565, after treatment

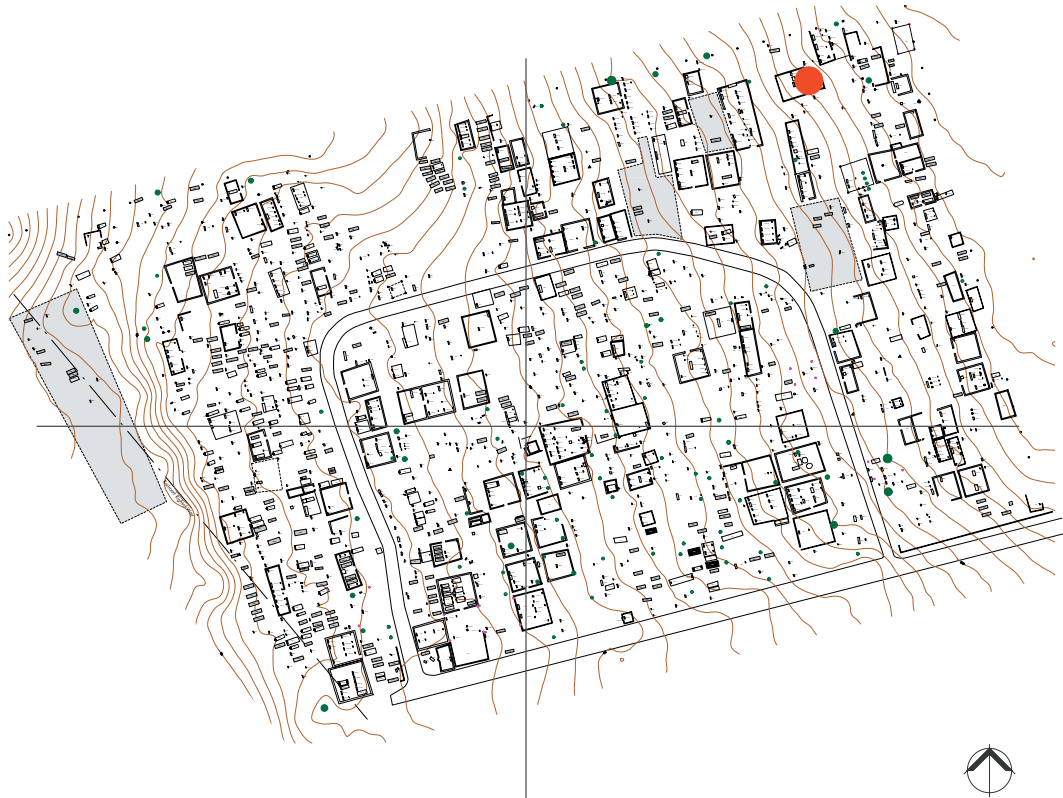
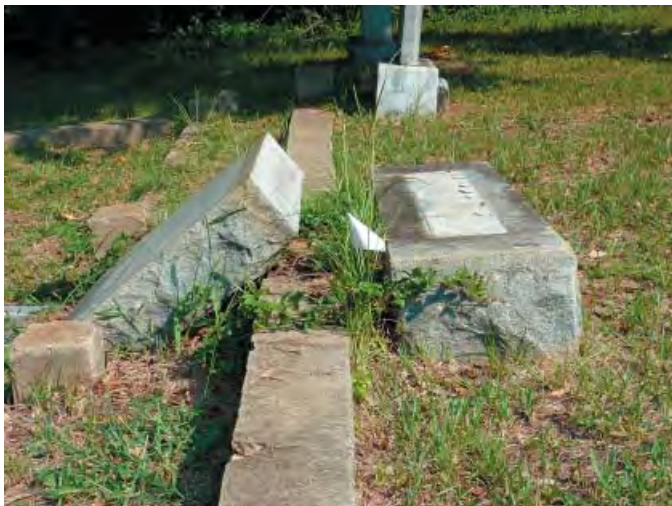
Figure 91: 0644.01, Octavia and Cyrus J. Butler marker, before treatment

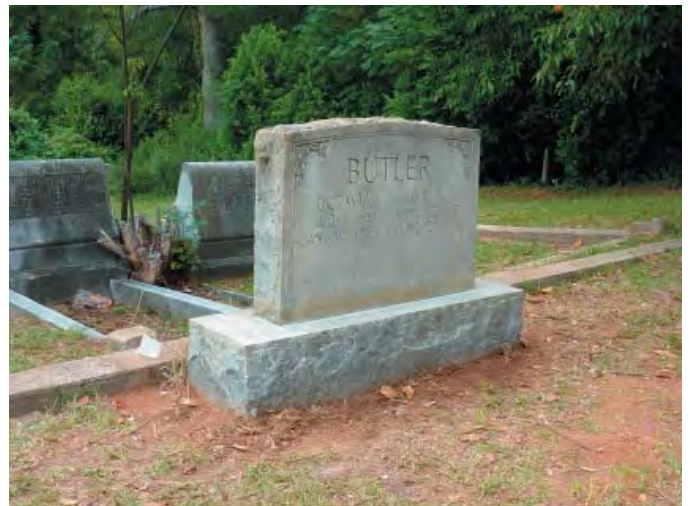
Figure 92: 0644.01, Octavia and Cyrus J. Butler marker, after treatment

Because the base was no longer level, it was carefully excavated and reset on a bed of approximately 2-inches of gravel and sand to aide in drainage. The headstone was raised and reset on the base on a bed of Premium Pre-Mixed Mortar Mix & Go from Virginia Lime Works.

After an appropriate dwell time, the granite was cleaned. A solution of water and Vulpex Liquid Soap was prepared using approximately ½-ounce of soap to 1-gallon of water. The solution was applied to the pre-wet surface and scrubbed using nylon bristle brushes. The surface was then thoroughly rinsed with clean water to remove all traces of the detergent. To remove any biological growth D/2 Biological Solution was applied to the dry granite at full strength. The solution was scrubbed periodically for approximately 5 minutes before thoroughly rinsing with clean water to remove all traces of the biocide. The joint between the headstone and base was pointed with Jahn Repair Mortar.

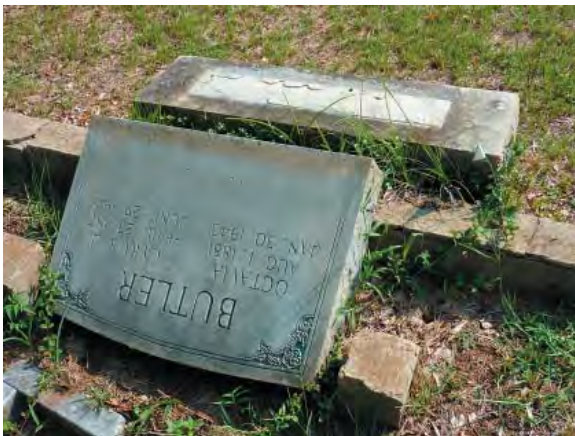
Figure 93: 0644.01, before treatment

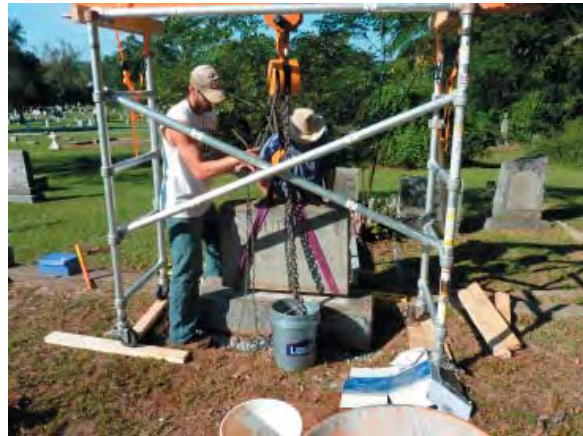
Figure 94: 0644.01, resetting headstone

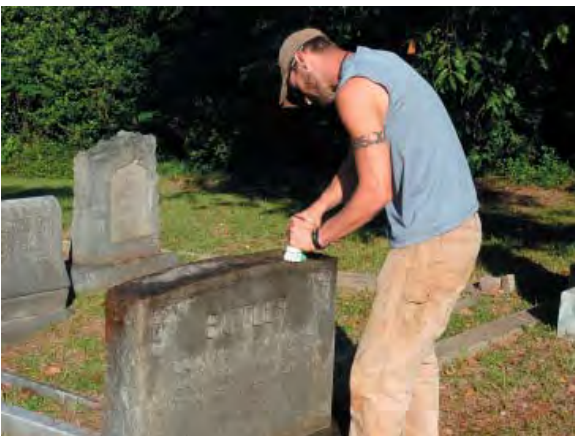
Figure 95: 0644.01, cleaning marker

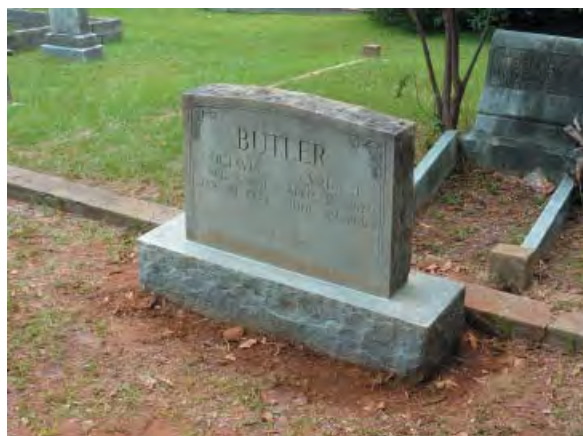
Figure 96: 0644.01, after treatment

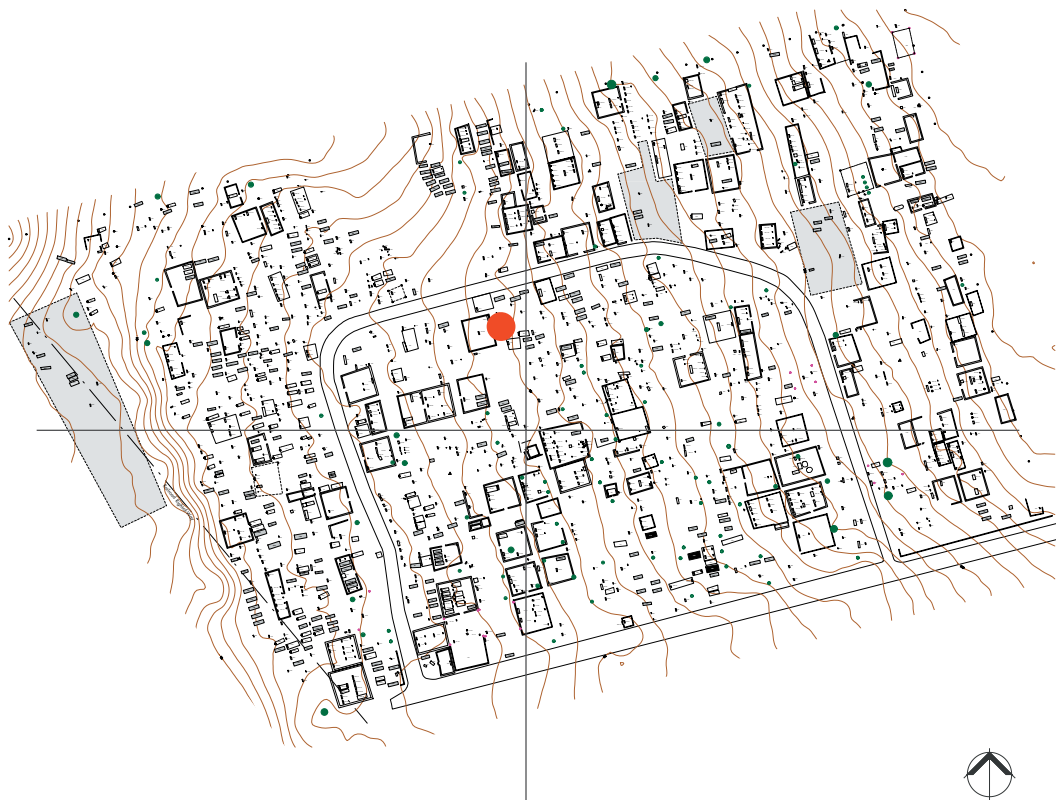
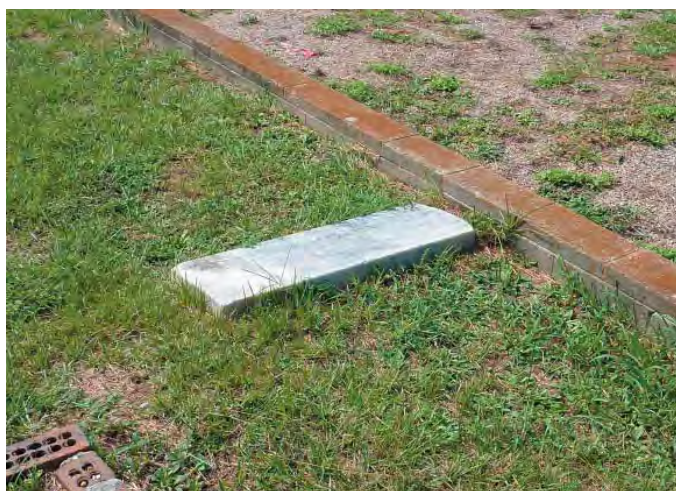
Figure 97: 0794, Samuel Young marker, before treatment

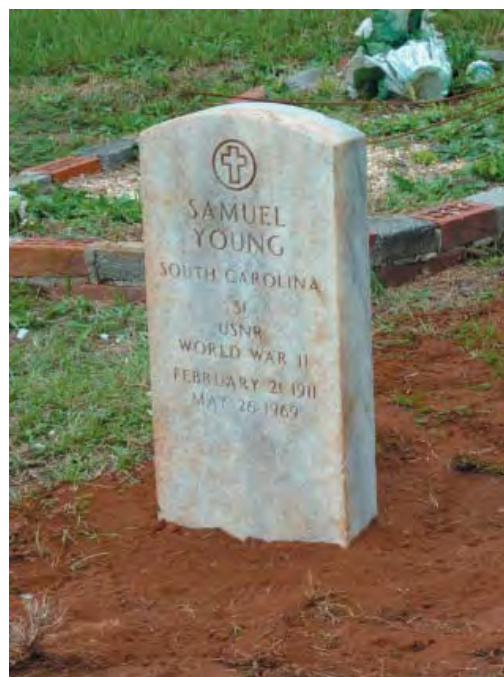
Figure 98: 0794, Samuel Young marker, after treatment

The marker was carefully excavated and cleaned. A solution of water and Vulpex Liquid Soap was prepared using approximately $\frac{1}{2}$ -ounce of soap to 1-gallon of water. The solution was applied to the pre-wet surface and scrubbed using nylon bristle brushes. The surface was then thoroughly rinsed with clean water to remove all traces of the detergent. To remove any biological growth D/2 Biological Solution was applied to the dry marble at full strength. The solution was scrubbed periodically for approximately 5 minutes before thoroughly rinsing with clean water to remove all traces of the biocide. The marker was then reset on a new bed of gravel and sand, approximately 2-inch deep, and leveled.

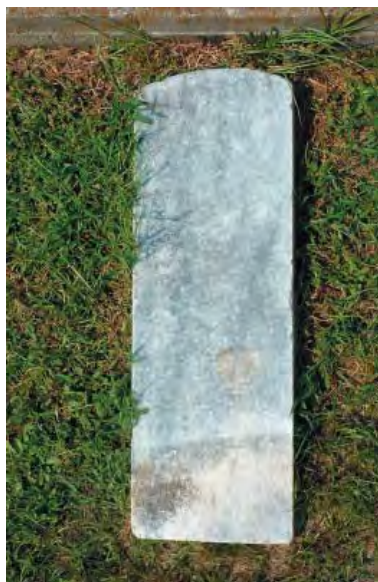
Figure 99: 0794, before treatment

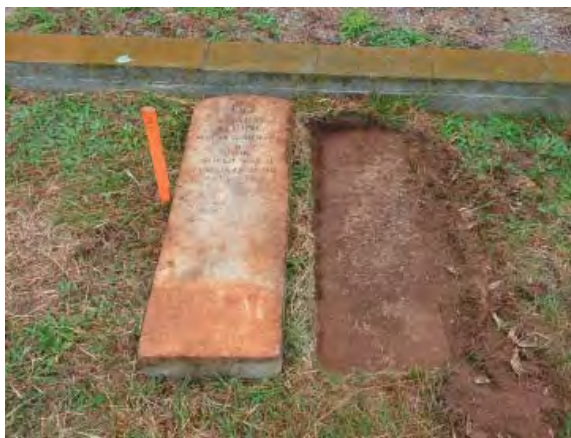
Figure 100: 0794, marker excavated

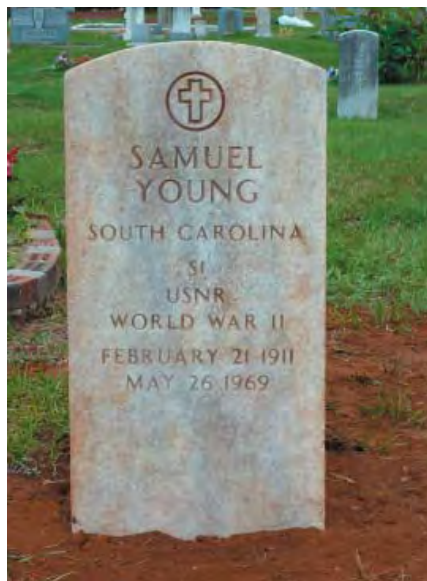
Figure 101 0794, after treatment

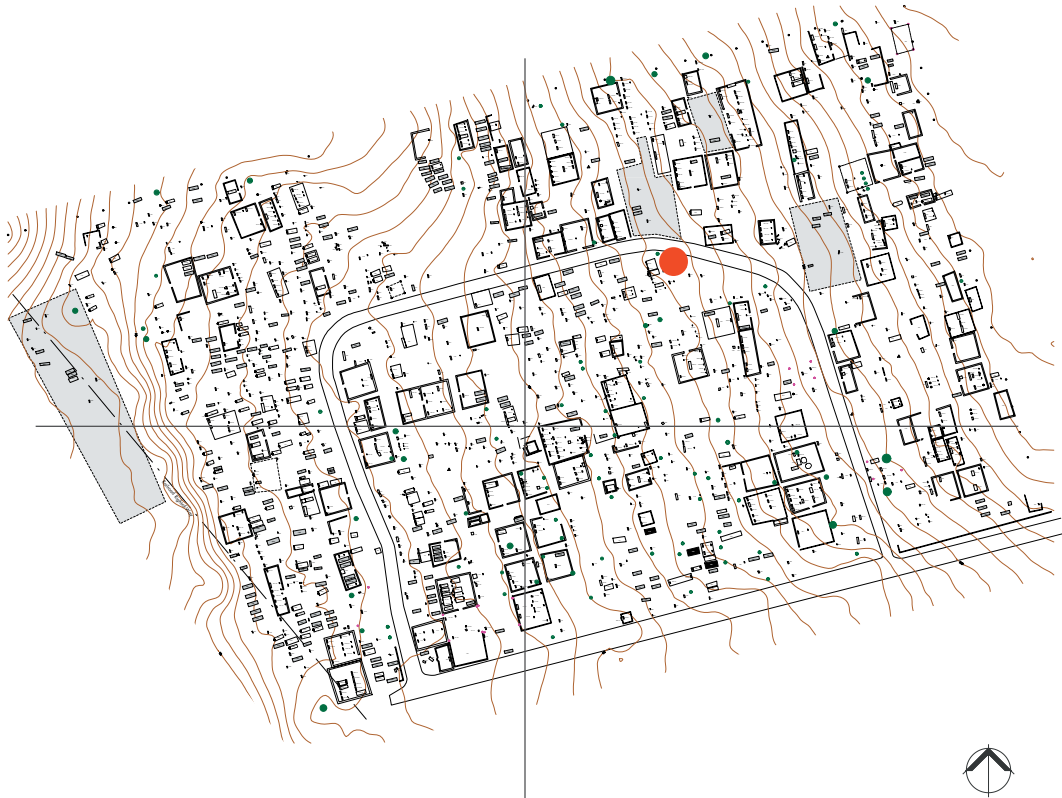
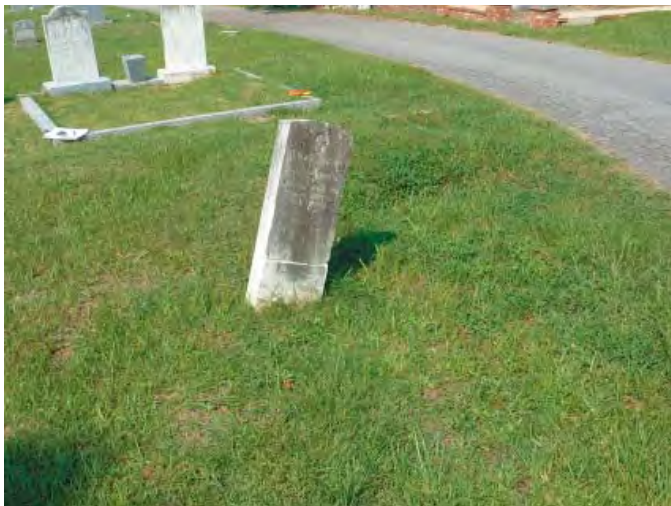
Figure 102: 0903, Henry Means marker, before treatment
