RANDOLPH CEMETERY
(1872)

PHASE III CONSERVATION REPORT

OCTOBER 7, 2011

COMMITTEE FOR THE RESTORATION AND BEAUTIFICATION OF RANDOLPH CEMETERY

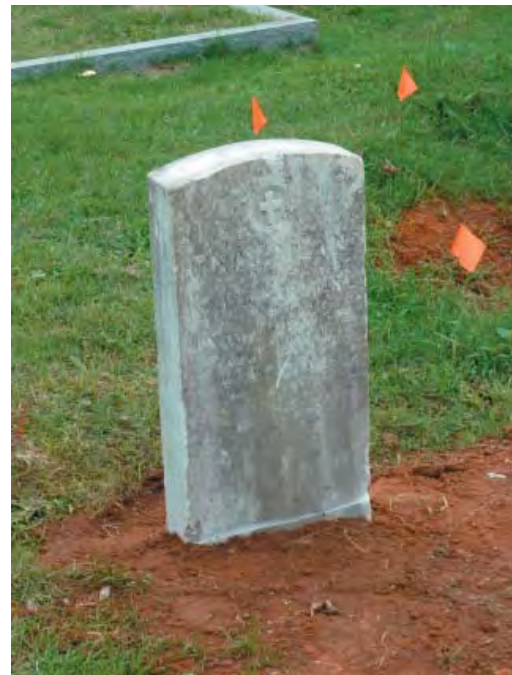
Figure 103: 0903, Henry Means marker, after treatment

The marker was carefully excavated and cleaned. A solution of water and Vulpex Liquid Soap was prepared using approximately ½-ounce of soap to 1-gallon of water. The solution was applied to the pre-wet surface and scrubbed using nylon bristle brushes. The surface was then thoroughly rinsed with clean water to remove all traces of detergent. The extensive biological growth necessitated the use of D/2 Biological Solution. The biocide was applied to dry marble at full strength. The solution was periodically for approximately 5 minutes before thoroughly rinsing with clean water to remove all traces of biocide. The marker was then reset on a new bed of gravel and sand, approximately 2-inch deep, and leveled.

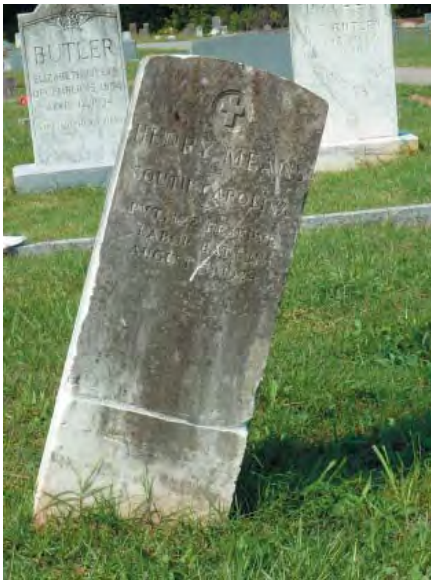
Figure 104: 0903, before treatment

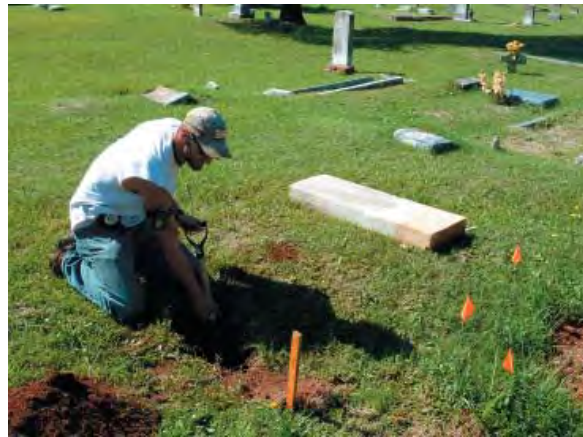
Figure 105: 0903, digging hole for marker

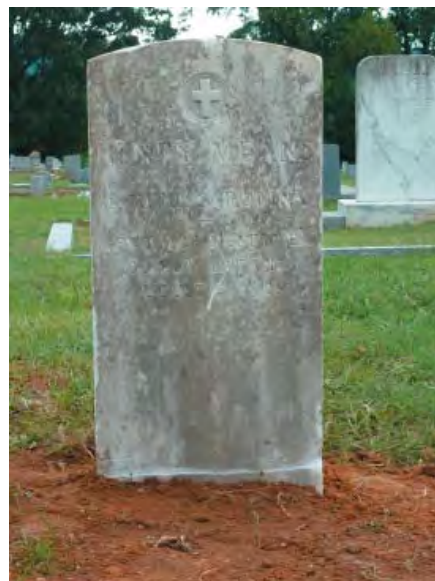
Figure 106: 0903, after treatment

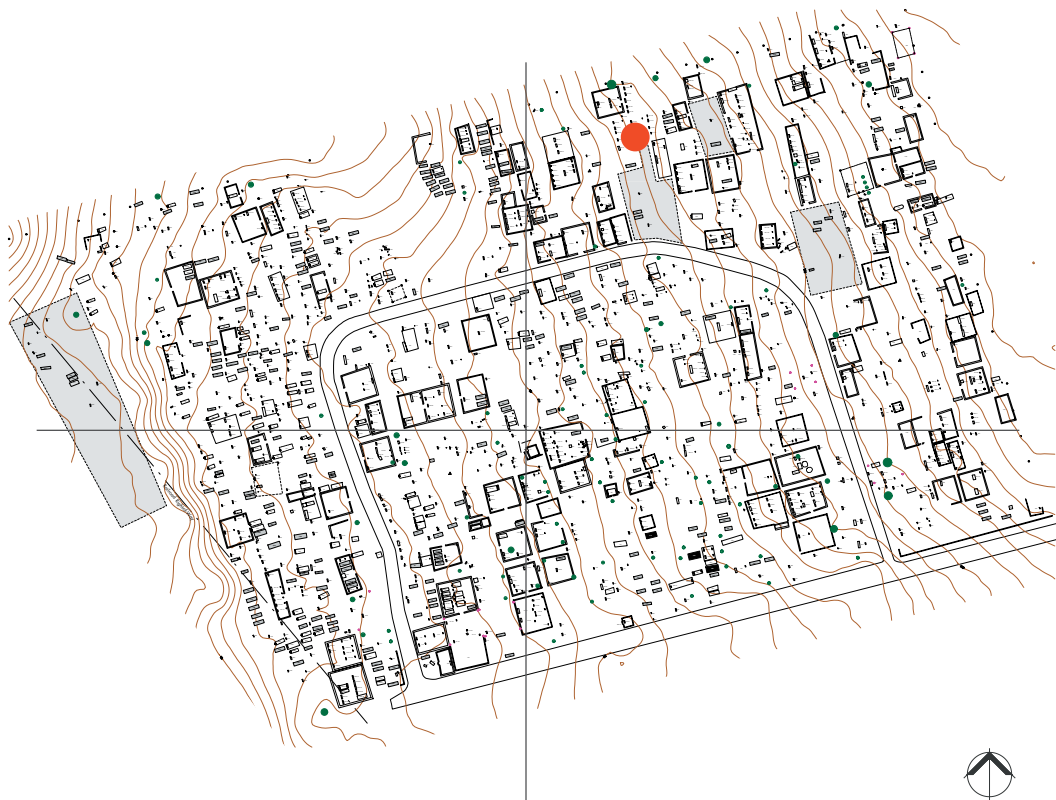
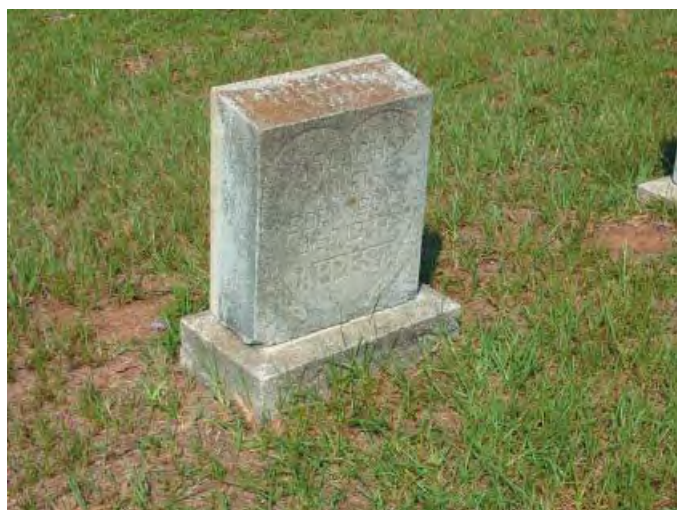
Figure 107: 0913.04, Isaac H. Aiken marker, before treatment

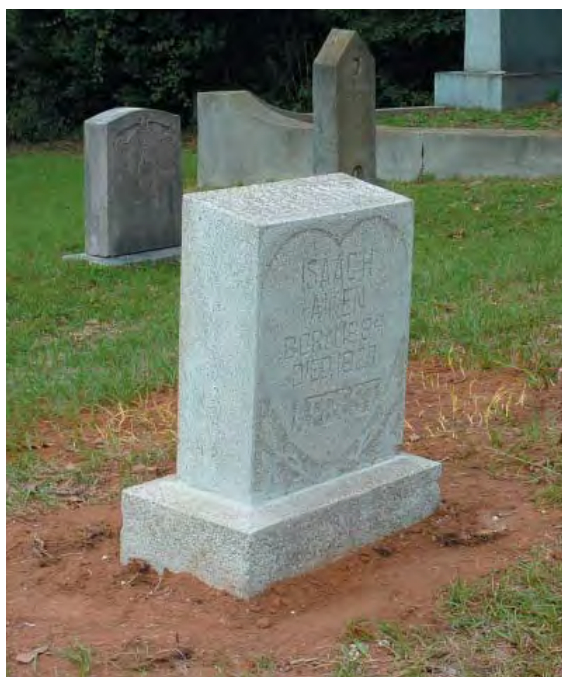
Figure 108: 0913.04, Isaac H. Aiken, after treatment

The concrete was excavated and all traces of mortar were carefully chipped off. The concrete was then cleaned of dirt and biological growth. A solution of water and Vulpex Liquid Soap was prepared using approximately 1/2-ounce of soap to 1-gallon of water. The solution was applied to the pre-wet surface and scrubbed using nylon bristle brushes. The surface was then thoroughly rinsed with clean water to remove all traces of detergent. The extensive biological growth necessitated the use of D/2 Biological Solution. The biocide was applied to dry concrete at full strength. The solution was periodically for approximately 5 minutes before thoroughly rinsing with clean water to remove all traces of biocide.

The base was reset on a level bed of approximately 2-inches of gravel and sand to promote drainage. The headstone was then reattached to its base using alloy 316 stainless steel threaded rods, 3/8-inch in diameter and 6-inches in length. The conservator drilled two holes into the bottom of the tablet and corresponding holes in the base. The pins were secured into the holes using SikaDur® 31 Epoxy. (Refer to Diagram 19 for pin locations). The joint between the headstone and base was pointed using Jahn Repair Mortar.

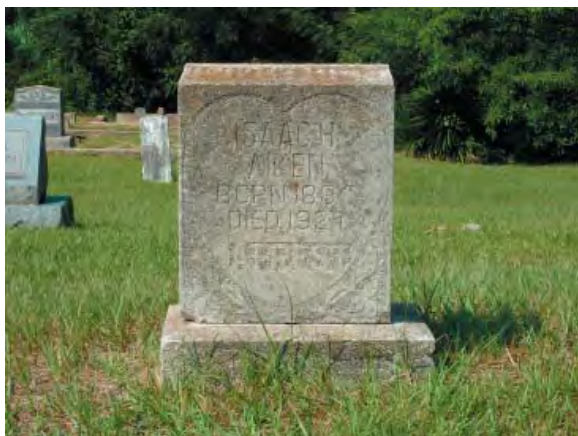
Figure 109: 0913.04, before treatment

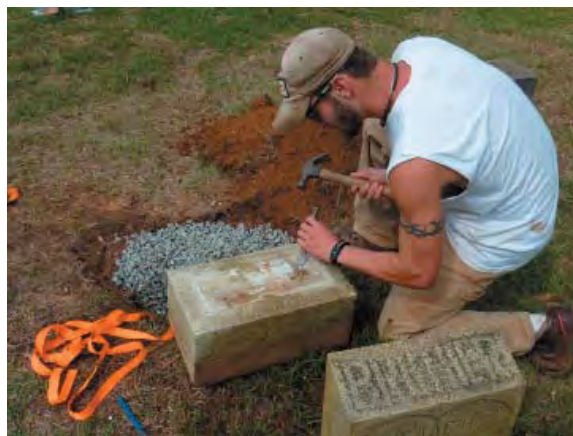
Figure 110: 0913.04, removing mortar

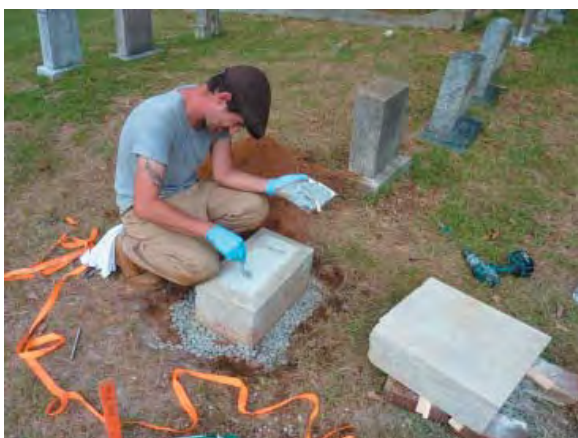
Figure 111: 0913.04, preparing marker for pinning

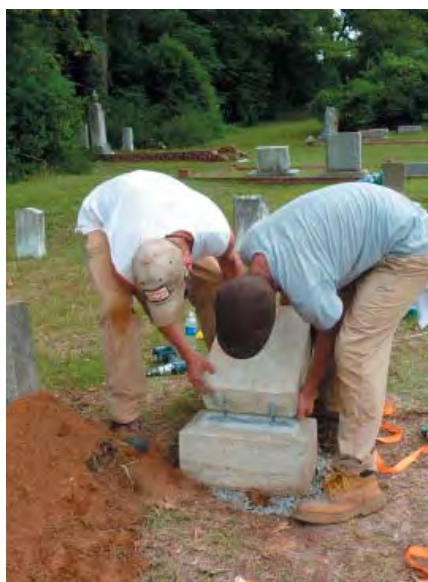
Figure 112: 0913.04, reattaching headstone

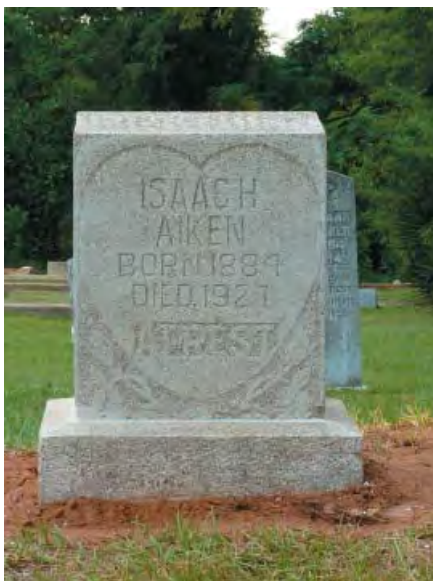
Figure 113: 0913.04, after treatment

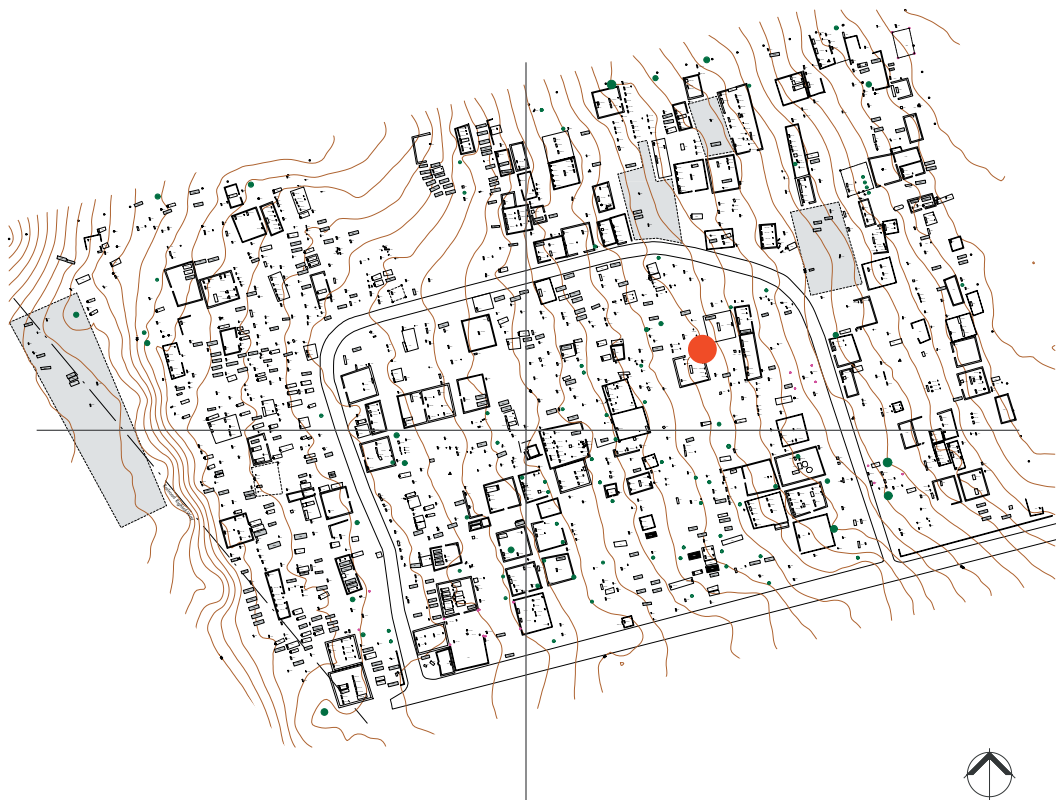
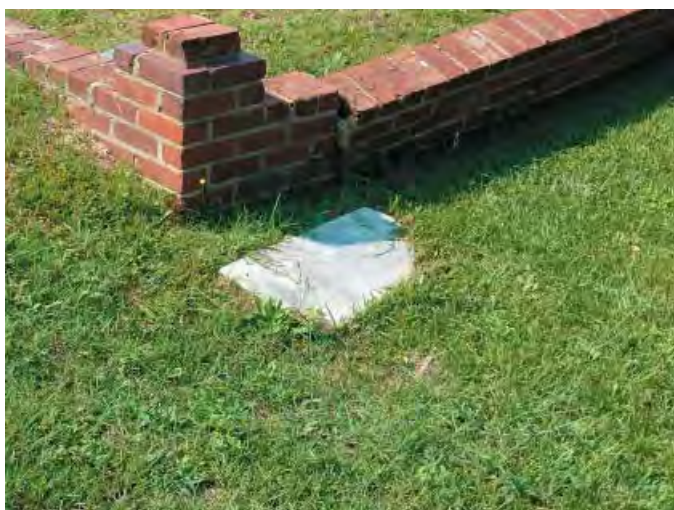
Figure 114: 0969, Fannie Hart marker, before treatment

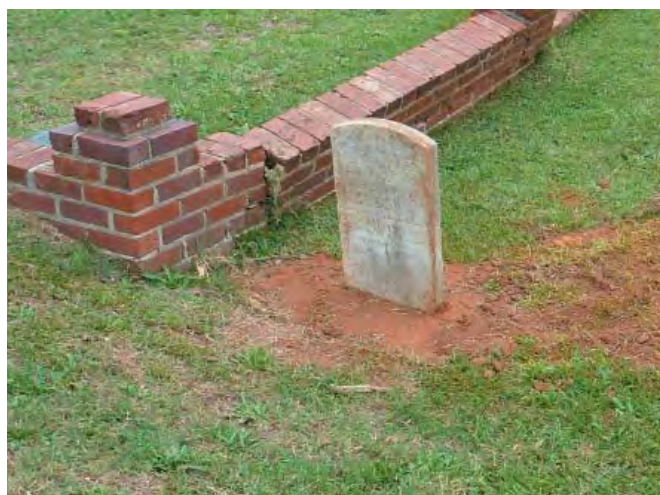
Figure 115: 0969, Fannie Hart marker, after treatment

The marble was cleaned of dirt and biological growth. A solution of water and Vulpex Liquid Soap was prepared using approximately ½-ounce of soap to 1-gallon of water. The solution was applied to the pre-wet surface and scrubbed using nylon bristle brushes. The surface was then thoroughly rinsed with clean water to remove all traces of the detergent. Biological growth was removed using D/2 Biological Solution. The biocide was applied to the dry marble at full strength and agitated using nylon bristle brushes. The solution was scrubbed periodically for approximately 5 minutes before thoroughly rinsing with clean water to remove all traces of the biocide.

No base was discovered below the marble tablet. Therefore, in order to reset the marker, it received a new base. This base, measuring 9-inches in height, 21-inches in width, and 9-inches in depth, was made of Quikrete Crack Resistant Concrete. The base socket, in which the tablet would sit, measured 3-inches deep, 15-inches wide, and 3-inches thick. The base was completely buried, sitting on 2-inches of level gravel and sand to promote drainage. The socket was partially filled with Premium Pre-Mixed Natural Hydraulic Lime Mortar from Virginia Lime Works. The tablet was set into the socket at which point the remaining void was filled with the mortar.

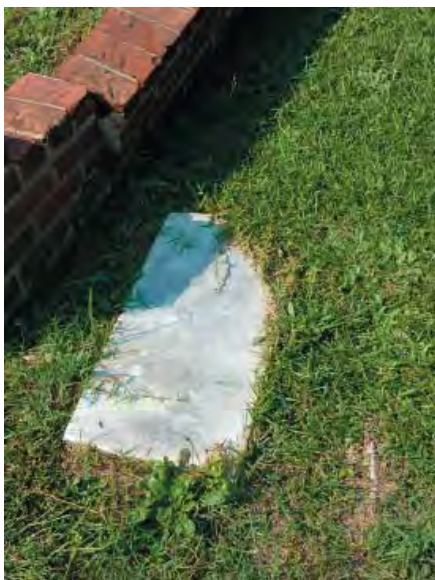
Figure 116: 0969, before treatment

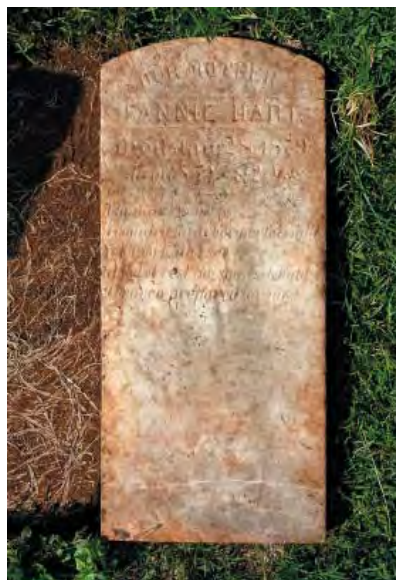
Figure 117: 0969, tablet excavated

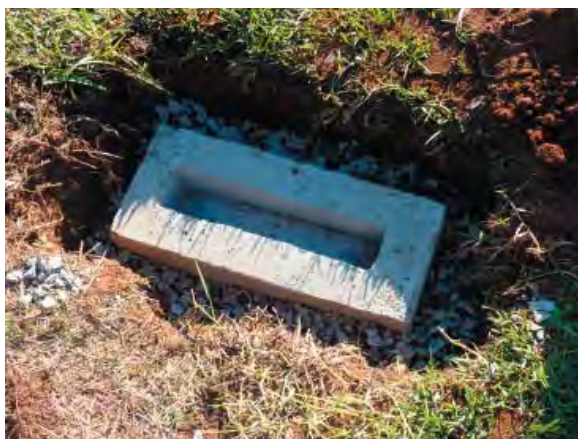
Figure 118: 0969, new base set

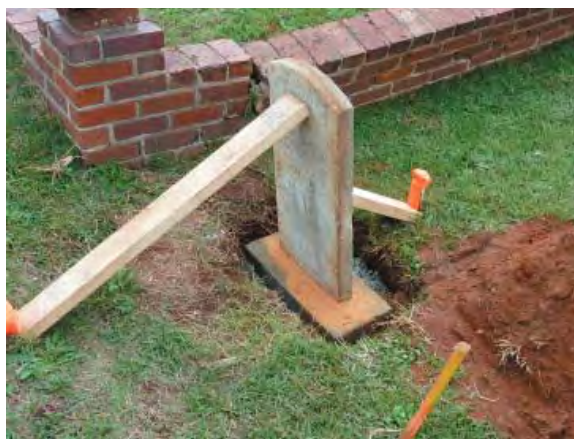
Figure 119: 0969, marker installed

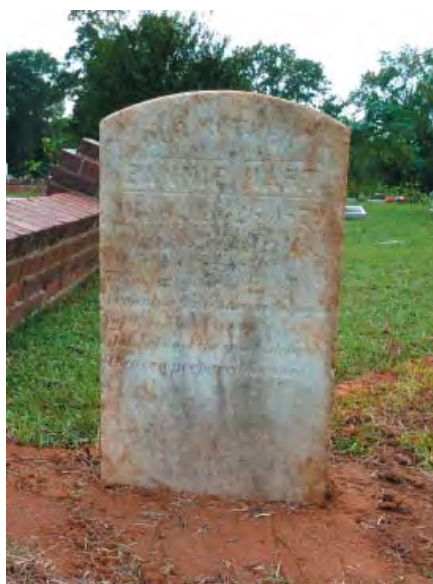
Figure 120: 0969, after treatment

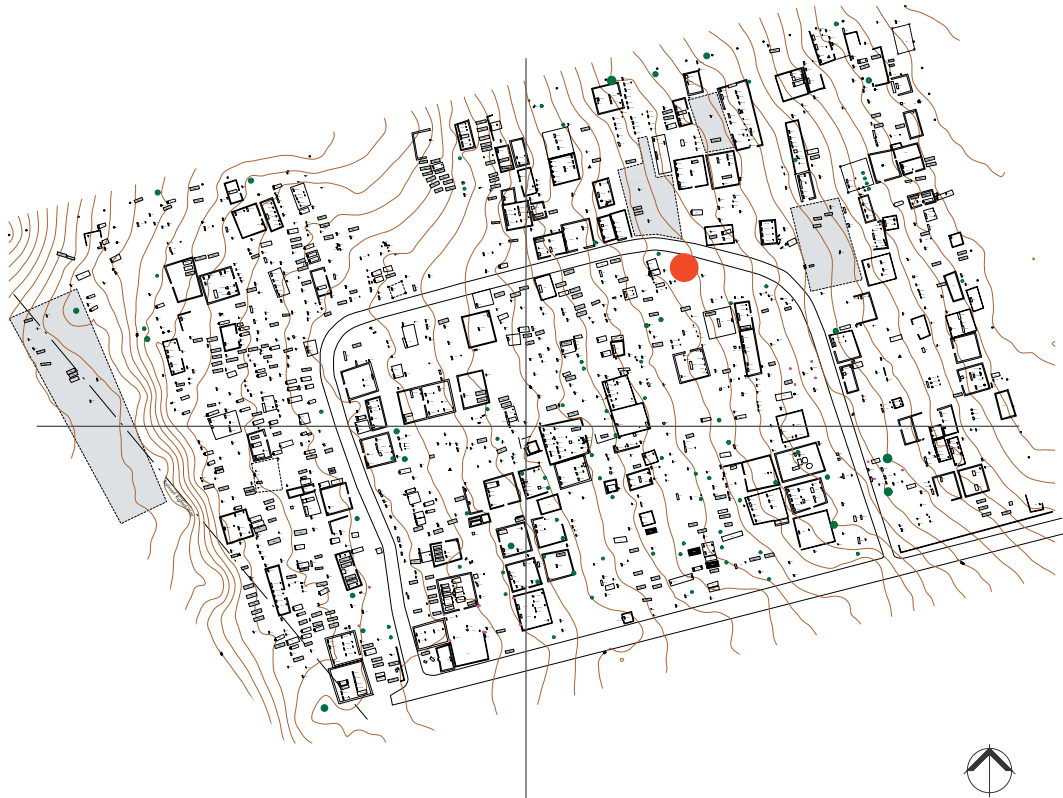
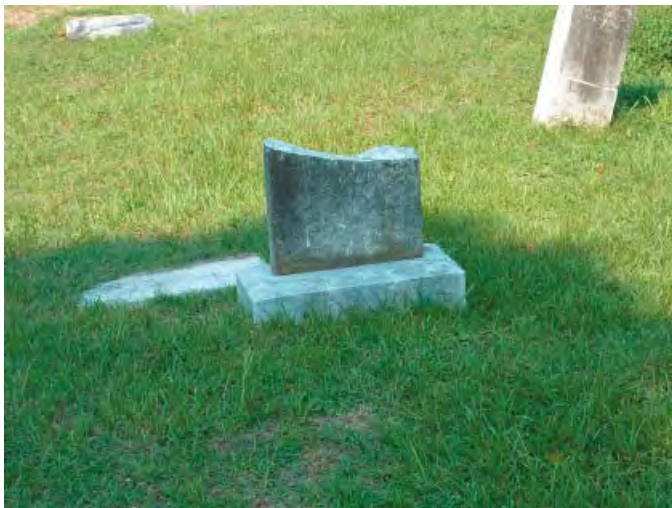
Figure 121: 0974, Jane M. Garner marker, before treatment

The marker for Jane M. Garner is located in the northeast quadrant of the cemetery at the south side of the looped road. The marker is a marble base and marble roundtop tablet. The base measures 9-inches in height, 22½-inches in width, and 10 inches in depth; the tablet measures 33½-inches in height, 16-inches in width, and 2⅛-inches in depth. The tablet was broken in half with the upper half lying face up behind the marker and the bottom half was still attached to the base, which was no longer level.

The base was reset, now sitting on 2-inches of level gravel and sand to promote drainage. The tablet was then repaired. The conservator drilled holes midway on the vertical breaks. Two alloy 316 stainless steel threaded rods, ⅜- and ¼-inch in diameter and 6-inches long, were used to connect the holes across the break. The pins were secured into the holes using SikaDur® 31 Epoxy. Additionally, the conservator spread a thin layer of the epoxy on the broken faces of the marble. (Refer to Diagram 21 for pin locations).

Once the marker was repaired and reinstalled, the areas of loss were filled with Jahn Marble Repair Mortar to prevent water infiltration and create a more cohesive surface appearance. The marble was prepared by using a Dremel to create a shoulder approximately ⅛-inch in depth for the patch material to effectively key into. The areas to be patched were moistened with clean water, at which point the Repair Mortar was applied. A mix of colors was used to better match the marble; this consisted of Jahn M120 28355-MA-3 (buff), Jahn M120 S1-MA (white), and Jahn M120 283357-MA-5 (dark gray). The Repair Mortar was further tinted using dry pigments and potassium silicate to blend with the surrounding stone.

Microcracks within the marble were addressed by grouting to limit water infiltration. After wetting the cracks, the grout, Jahn Masonry Repair M30 Micro Injection Grout, was inserted into the voids using a syringe. The joint between the tablet and base was pointed with Jahn Repair Mortar.

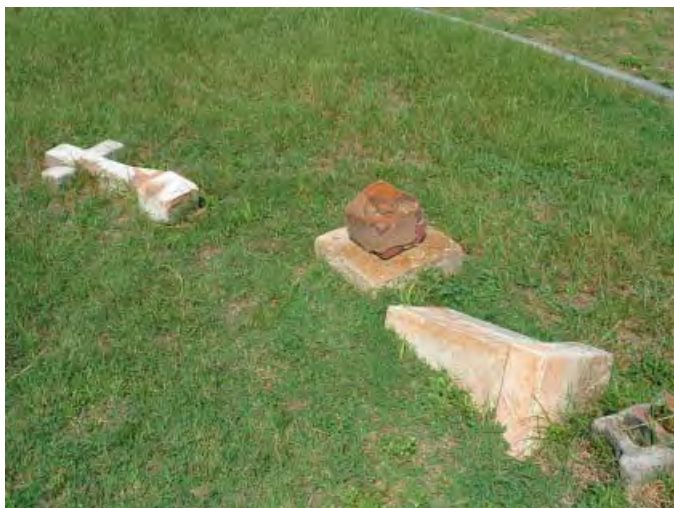
Figure 128: 0980/0981, C.W. Dunlap marker, before treatment

The pedestal was no longer connected to the base and plinth and cross, leaving the pedestal, plinth and cross lying on the ground and the base upside down. The marker had been previously repaired; mortar attached a broken corner of the cross and attached the cross to the plinth, though out of line. One arm of the cross was broken and there was material missing.

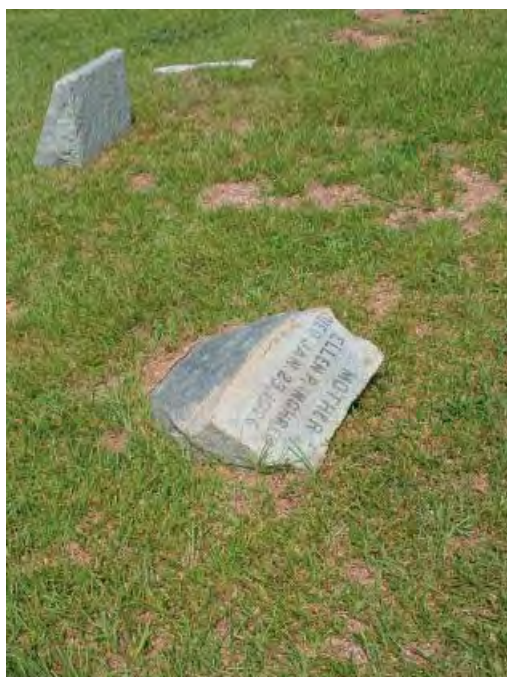
Figure 137: 0986, Ellen P. Inghren marker, before treatment

The marker for Ellen P. Inghren is located in the northeast quadrant of the cemetery. The granite raised top style marker is irregular in shape with rusticated sides. Its approximate measurements are 25-inches in height, 18-inches in width, and 10½-inches in depth. The marker was partially lying on the ground.

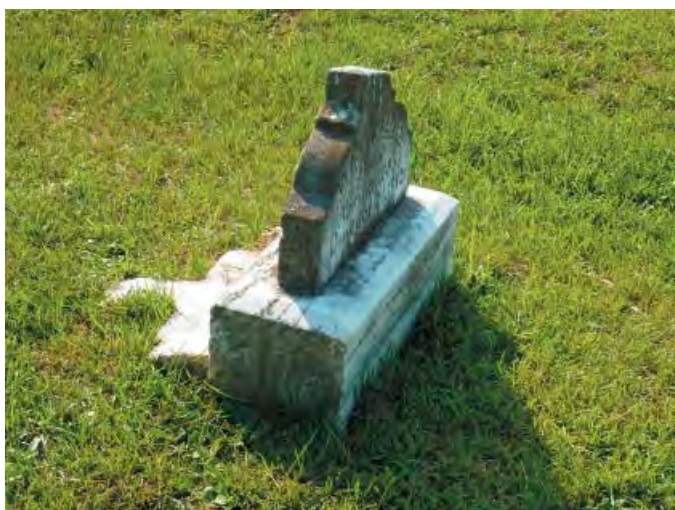
Figure 142: 0990, Jesse D. Lykes marker, before treatment

The marker for Rev. Jesse Lykes is located in the northeast quadrant of the cemetery. The marker is a fine-grained marble sub-base, base and cross. The sub-base measures 3½-inches in height, 34-inches in width, and 10-inches in depth; the base measures 10¼-inches in height, 24-inches in width, and 10-inches in depth; the cross measures 32¼-inches in height, 18-inches in width (at the arms of the cross), and 3-inches in depth. The cross was broken into three pieces; the bottom section was still attached to the base and the upper sections were lying on the ground. The base was not level and all of the marble was blackened with biological growth.

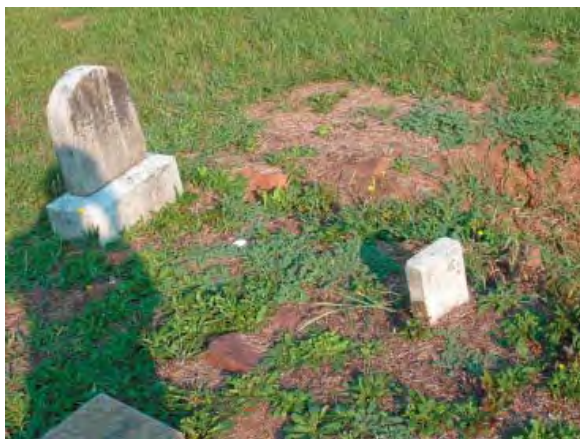
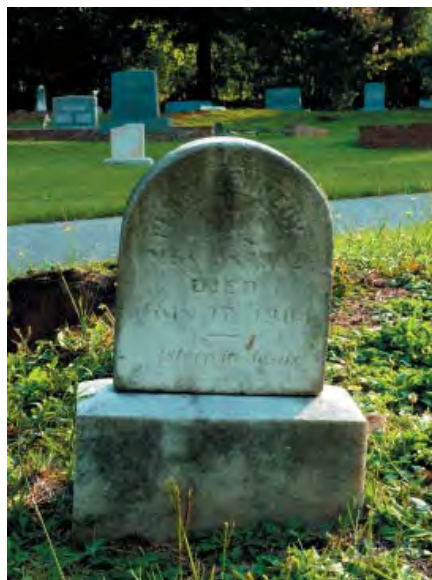
Figure 149: 1005, before treatment

The existing wall consisted of two stretching courses atop a brick bonding foundation course. It did not appear that the brick had been mortared together. In order to rebuild the small boundary wall, the outline of the wall was marked and all of the bricks were excavated and cleaned. The ground from the marker to the road was graded to further fill in the hole remaining from the tree stump. An inadequate number of bricks were discovered to rebuild the wall in its original fashion. Therefore to avoid adding bricks not original to the site and to create a more stable wall, a slightly different design was employed. A foundation of Quikrete Crack Resistant Concrete was poured. The grade of the land at the western end necessitated a step down of the foundation and creation of an additional half course of brick at this end. Two stretching courses of brick was laid atop of the foundation and was set and pointed with Holcim Mortamix Type N Mortar, Oyster White. The new wall is approximately 94-inches long and 34-inches wide with a cross wall at the west end. The wall was cleaned as necessary to remove excess lime on the brick from the new mortar. Vana Trol®, an acidic cleaner, was diluted with clean water at a ratio of 1:6. The surface of the brick was wet with water and solution was applied and lightly agitated with nylon bristle brushes. After a dwell time of approximately 2 minutes, the brick was thoroughly rinsed with clean water.

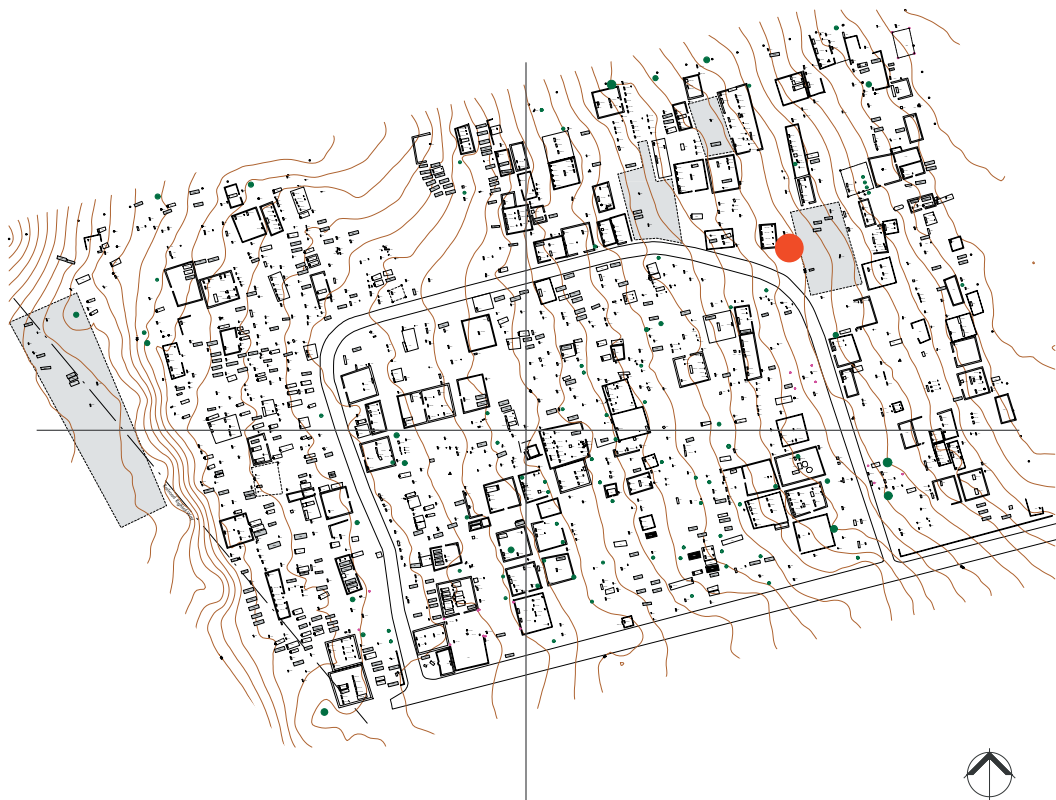
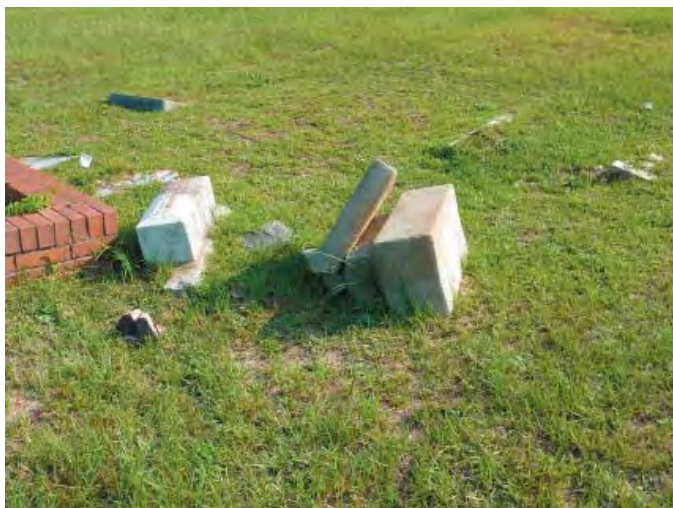
Figure 161: 1013/1016, Girlie Nesbit marker, before treatment

The marker for Girlie Nesbit is located in the northeast quadrant of the cemetery. The marker consists of a concrete base, plinth, headstone and bedstead (original thought to be marker #1016). The headstone is adorned with a dove, a lamb, and the plinth with shaking hands. The base measures 8½-inches in height, 24-inches in width, and 13-inches in depth; the plinth measures 3¾-inches in height, 20-inches in width, and 9-inches in depth; the headstone measures 28½-inches in height, 15½-inches in width, and 4-inches in depth. At the time of the survey, the headstone was broken into three pieces and lying on its side approximately 4-feet from the mostly buried bedstead.

A new hole was dug at the west end of the excavated bedstead for the base. The hole was filled with approximately 2-inches of gravel and sand and leveled. The base was set here and the broken concrete was then pinned back together. The conservator drilled holes midway on the vertical of the breaks. Alloy 316 stainless steel threaded rods were used to connect the holes across the breaks. One pin ¼-inch in diameter and 5-inches long connected the bottom of the headstone to the smaller middle section and again to the upper section. The large missing portion across the middle led to the use of a longer pin, ⅜-inch in diameter and 14-inches long, to span the opening. The pins were secured into the holes using SikaDur® 31 Epoxy. Additionally, the conservator spread a thin layer of the epoxy on the broken faces of the marble. (Refer to Diagram 26 for pin locations).

A level foundation of approximately 2-inches of gravel and sand followed by approximately 2-inches of Quikrete Crack Resistant Concrete was poured for the bedstead. The bedstead pieces were set on a bed of Premium Pre-Mixed Mortar Mix & Go from Virginia Lime Works.

Once the marker was repaired, the areas of loss were filled with Jahn Concrete Repair Mortar to prevent water infiltration and create a more cohesive surface appearance. The concrete was prepared by using a Dremel to create a shoulder a minimum of an ⅛-inch in depth for the patch material to effectively key into. The areas to be patched were moistened with clean water, at which point Jahn M90 S1-CR was applied. The patches were sculpted to the appropriate surface level. The Repair Mortar was further tinted with dry pigments and potassium silicate to blend with the surrounding concrete.

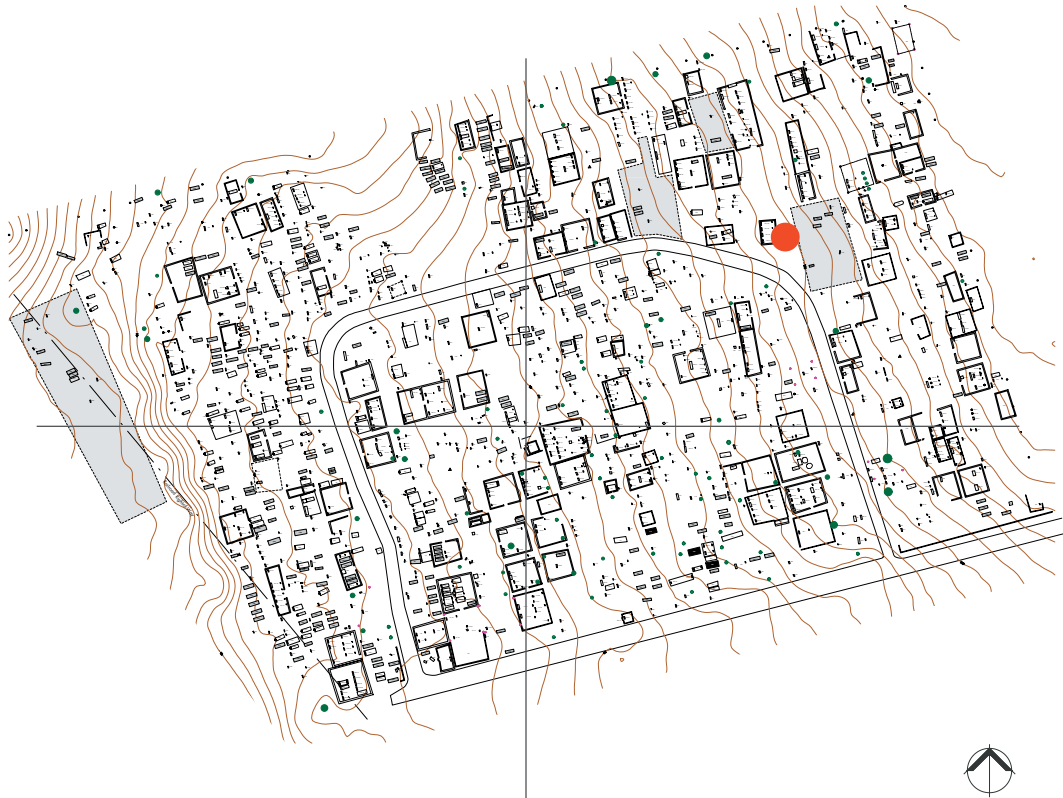
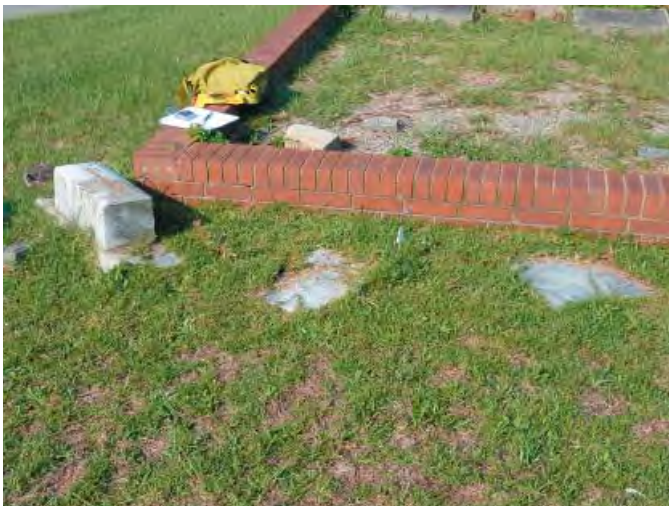
Figure 173: 1014, Caroline Louisa Cooper marker, before treatment

The marker for Carolina Louisa Cooper is located in the northeast quadrant near the looped road. The marble sub-base measures approximately 2-inches in height, 32-inches in width and 10-inches in depth; the marble base measures 7-inches in height, 22 $\frac{1}{4}$ -inches in width, and 8-inches in depth; the roundtop marble tablet measures 31 $\frac{3}{8}$ -inches in height, 18-inches in width, and 2-inches in depth. The tablet was broken from the die in socket base and was also broken into three pieces. All sections of the marker were spread out along a nearby boundary wall and were partially buried.

The broken marble was pinned back together. The conservator drilled holes midway on the vertical of the breaks. Five alloy 316 stainless steel threaded rods, $\frac{1}{4}$ -inch in diameter and 4-inches long and $\frac{3}{8}$ -inch in diameter and 6-inches long, were used to connect the holes across the breaks. The pins were secured into the holes using SikaDur® 31 Epoxy. Additionally, the conservator spread a thin layer of the epoxy on the broken faces of the marble. (Refer to Diagram 27 for pin locations).

Once the marker was repaired and reinstalled, the areas of loss were filled with Jahn Marble Repair Mortar to prevent water infiltration and create a more cohesive surface appearance. The marble was prepared by using a Dremel to create a shoulder approximately $\frac{1}{8}$ -inch in depth for the patch material to effectively key into. The areas to be patched were moistened with clean water, at which point the Repair Mortar was applied. A mix of colors was used to better match the marble; this consisted of Jahn M120 28357-MA-5 (dark gray), Jahn M120 28356-MA-2 (light gray) and Jahn M120 S1-MA (white). The patches were screeded to the appropriate surface level. The Repair Mortar was further tinted with dry pigments and potassium silicate to blend with the surrounding stone.

Microcracks within the marker were addressed by grouting to limit water infiltration. After wetting the cracks, the grout, Jahn Masonry Repair M30 Micro Injection Grout, was inserted into the voids using a syringe. The joint between the tablet and base was pointed using Jahn Repair Mortar.

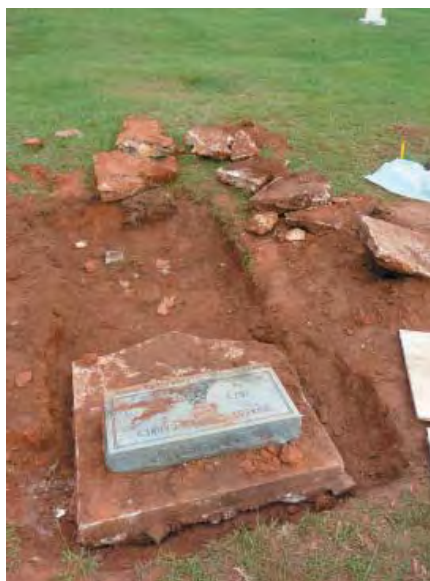
Figure 188: 1015, concrete foundation excavated

To raise the marker it was excavated. As this process began, it was discovered that the granite was attached to a large, broken concrete foundation. All pieces of the foundation were excavated and surface dirt was removed to ensure that there was no inscription on the surface. The pieces of the foundation and headstone were placed back onto a higher, level surface of dirt and gravel. The foundation was then reburied by 2 to 4-inches of dirt.
