Richland County Council

PROPERTY DISTRIBUTION MANAGEMENT AD HOC COMMITTEE OCTOBER 2, 2018 – 3:00 PM 4th Floor Conference Room 2020 Hampton Street, Columbia, SC 29204

The Department of Operational Services performed a preliminary space evaluation on the Burlington retail space located at the Columbia Place Mall at 7201 Two Notch Rd. on November 13th, 2017 between 10:00 am and 12:30 pm. During the preliminary evaluation, the building's main systems were observed and an overall assessment was determined, including the following:

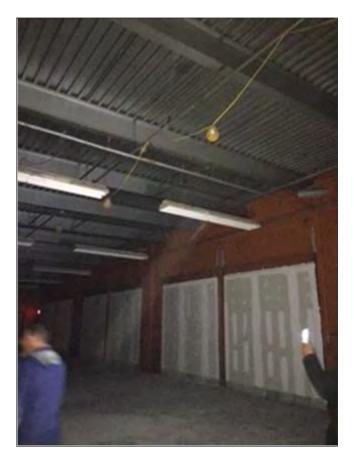
It was observed that the building structure consisted of a steel column and beam structure with concrete floors over a metal deck. The exterior of the building was a mixture of brick veneer, block walls, and an EFIS system (Exterior Finish Insulation System). The main structure of the building appeared to be in good shape, with no observed structural cracks in the concrete, nor any major rusting on the steel or any structural members out of position or missing. The exterior of the building also appeared to be in decent shape. The team did not observe any cracks in the foundation, nor in any of the exterior brick. The EFIS system seemed intact and did not give the impression of any water infiltration, which is a common issue with this type of system. An outside consultant can be engaged to ensure the integrity of the EFIS system.

Structural construction in old auto bays

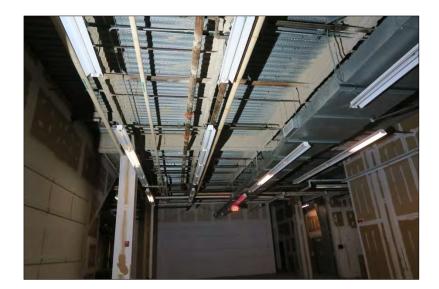
Typical structure (beams and columns with metal deck)- shown in storage area

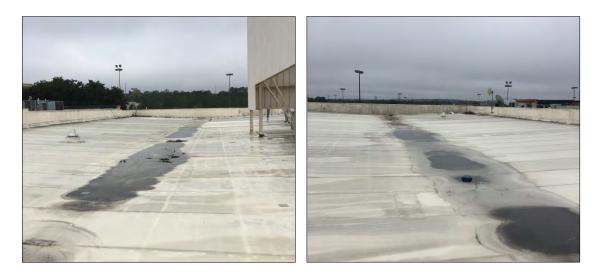
The roof structure looks to be operational, but appears to be about ten years old and is expected to have approximately five to seven (5-7) years of lifespan remaining. However, it was observed that certain areas, especially in the roof drain valleys, that continuous ponding was present due to improper slope. This could be due to the underlying insulation compressing over time, or due to water infiltration saturating the insulation. A few coring samples would need to be done to determine the exact cause, and this should be done by an outside consultant. It would be the department's recommendation to have the roof replaced as part of a major renovation of the space to avoid future failures or to interfere with daily operations once the building is occupied.

Burlington roof

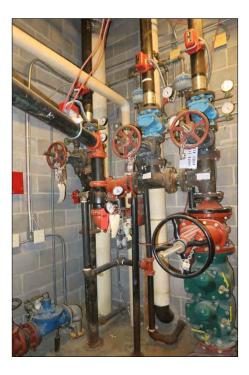
The existing structure has a fire sprinkler system installed. The design of the system is conducive for open warehouse or retail space. The sprinkler system would need to be reviewed and possibly modified to accommodate office space. All new branch plumbing will be required to protect each individual office and also account for the increase in occupancy load. The main trunk lines would need to be evaluated by an outside engineering source specializing in sprinkler designs to determine if the water flow on the main trunk lines is sufficient given the new intended use.

The fire alarm system which is typically tied into the fire sprinkler system was observed during the walk-through as encountering an issue. Therefore, we were not able to determine the operational condition of the system. The cause of the problem reading on the system would need to be addressed and resolved. The fire alarm system would need to be reviewed and possibly modified to accommodate office space.

Piping in the fire sprinkler control room

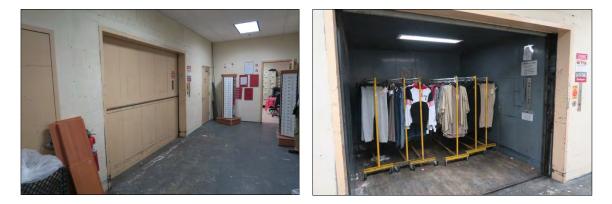
The onsite inspection observed a single freight, hydraulic elevator that moved between the areas near the loading dock to the current tenant's inventory space on the first floor. This elevator is operational at this time; however, it has not received a current Certificate of Operations license and therefore should not be operated until this license is obtained. An inspection of the elevator or a major renovation of the space may require the freight elevator to be upgraded to meet current codes. Additionally, this freight elevator should not be used to

transport persons from floor to floor; it is truly designed for freight and does not meet the requirements for transportation of people.

Freight elevator

Interior of freight elevator

The installation of passenger elevators will be required to provide personnel and those with disabilities movement from floor to floor. This will be a significant budget impact to the overall project cost and time due to having to create elevator shafts within the given space, a complex proposition in the best of circumstances that involves structural and mechanical elements. Currently the only means to transport from floor level to floor level would be to use the systems located in the core of the structure.

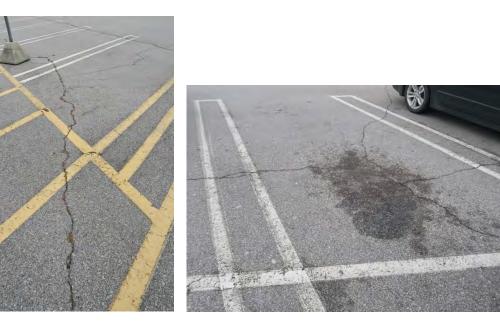
The parking lot appeared to be in operational condition. However, it did show some signs of wear and tear with the presence of cracks and raveling. It is recommended that the cracks be routered and sealed with the entire area treated with a topcoat. This would require the entire area to be restriped as well. This procedure should give the parking lot an additional five to ten

Typical cracking in pavement

Typical raveling

(5-10) years of usage with minimal maintenance. It should be budgeted in the future every seven to ten (7-10) years for a milling and repaying of the lot.

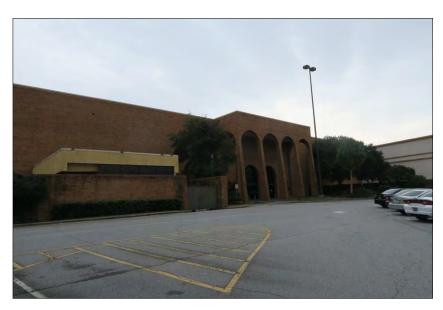
It was observed that the building structure consisted of a double T precast concrete deck structure placed on concrete columns and beams. The exterior of the building was a mixture of mostly brick veneer with a few block walls, and a little bit of an EFIS system (Exterior Finish Insulation System). The main structure of the building, of which could be observed, appeared to be in good shape, with no observed structural cracks in the concrete, nor did any of structural

Double "T" structure @ loading dock

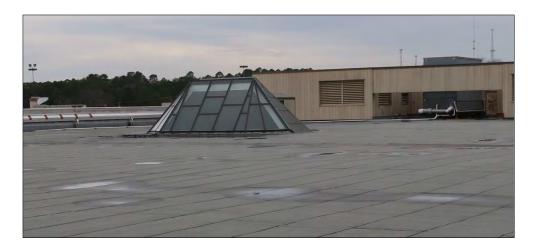
Skylight at atrium

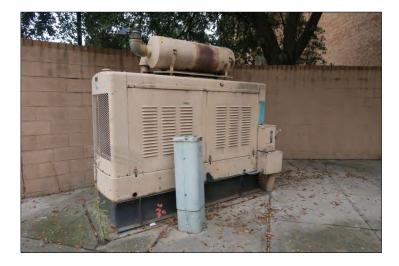
The space also had a small diesel fuel backup generator that appears to power just a few critical items, such as emergence lighting. This size generator is not capable of handling much of an electrical load beyond what it is currently supported. If the county intends to convert the space into an operational essential facility, it is this department's recommendation to upgrade the backup generator to a unit that would be capable to running the entire facility at full load. However, this design feature will have a significant financial impact on the overall project budget.

Backup generator

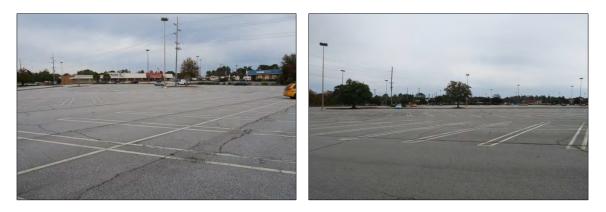
The parking lot appeared to be in operational condition. However, it did show some signs of wear and tear with the presence of cracks and raveling. It would be the department's recommendation that the cracks be routered and sealed with the entire area treated with a topcoat. This would require the entire area to be restriped as well. This procedure should give the parking lot an additional five to ten (5-10) years of usage, depending on vehicle counts, with minimal maintenance. It should be budgeted in the next seven to ten (7-10) years for a milling and repaving of the lot which will have a high construction cost.

Parking at Dillard's

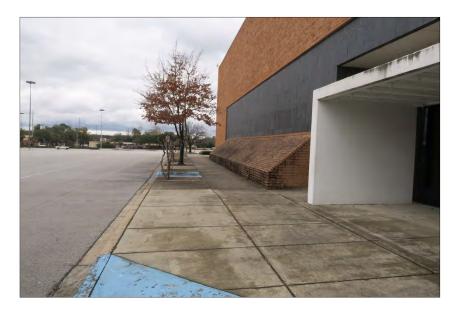
Brick exterior with some evidence of water issues

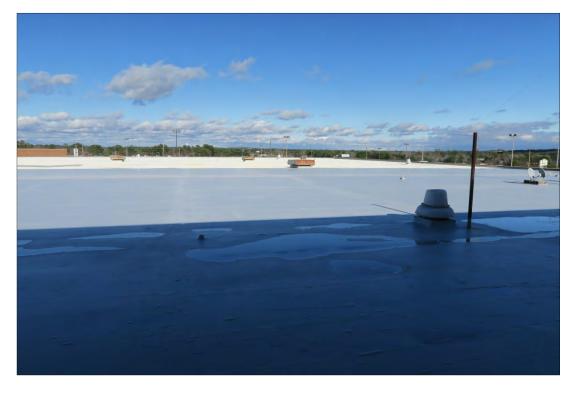
Roof showing the two different areas (the treated-gray and untreated areas-white)

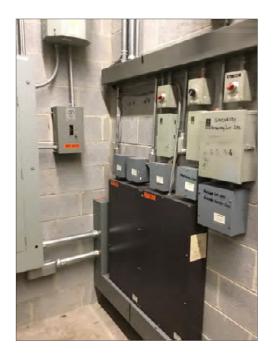
The lighting system throughout the space is mostly made up of 2x4 lay in lights utilizing T8 bulbs. The system appears to be controlled through a low voltage contact system.

Low-voltage controls

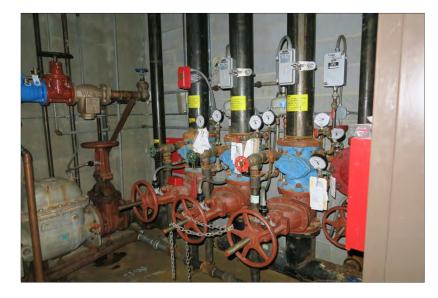
Fire sprinkler room with domestic water tap-in

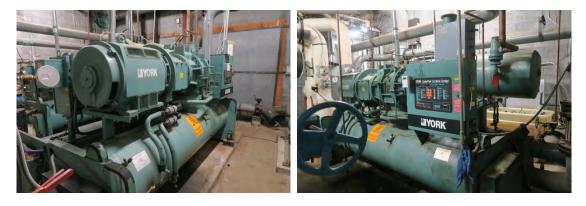
The HVAC equipment appears to be about 20 plus years old, when the majority of the equipment was installed in the mechanical penthouse. Equipment of this typical size generally has a 10 to 15 year lifespan, which means that this equipment has passed the end of its life expectancy. Depending on the County's space requirements, it is quite possible that the current units are undersized for an office space heat load. This would then need to be upgraded or at least supplemented by additional units. However, considering the age of the units, it would be this department's recommendation that the units be replaced/upgraded during any major renovations to avoid future failures or to interfere with daily operations once the building is occupied.

The total tonnage of the two chillers is 500 tons. Typically, every 200 – 250 square feet of office space requires approximately one ton of HVAC cooling capacity. This area has approximately 200,000 heated square feet, thus requiring approximately 800 total tons. Therefore, based on simple calculations, additional tonnage would be required to heat and cool office space in this area.

Chillers (1 and 2) in mechanical penthouse

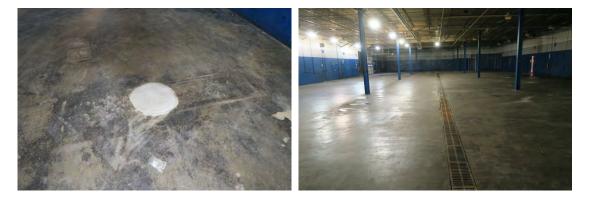
With the property having an auto repair shops on site that utilized in ground vehicle lifts with associated underground storage tanks, the site has some environmental concerns that need to be investigated. Additionally, it was observed that the battery storage area in the auto center has some acid damage that could also be an environmental concern. The floor drainage system in the auto area could also be a concern if it is not attached to an oil/water separator, thus leading to potential contamination of storm water or sewer system outflows.

Place of previously installed vehicle lift

It is the department's recommendation that a Phase I and Phase 2 environmental study be performed on this facility. This will allow discovery of any potential environmental hazards that need to be addressed or that could affect the property and its ability to meet the intended use. Depending on the results of these studies, findings could have a significant impact on the overall project budget.

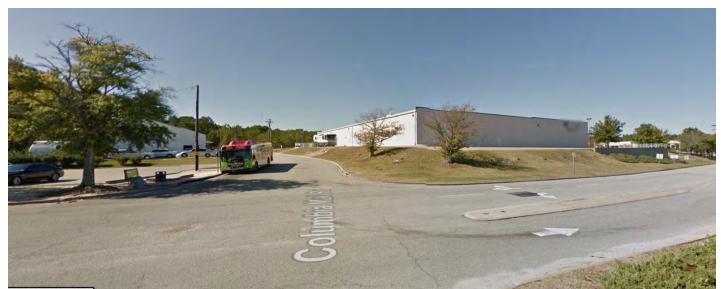
Image 2. Northeast Protection Connection Zone

Image 2 illustrates the Northeast CPZ. The unwillingness of property owners to grant easements has prevented this corridor from receiving the transit and pedestrian improvements warranted to make the location more accessible. Absent a facility for transit operations within CPM, The COMET is forced to operate on the outskirts. As a result, transit operations are dispersed along two unpaved curbs with the bare minimum of amenities. In its current condition, the Northeast CPZ is not merely unattractive for both pedestrians and transit passengers, it is completely inaccessible for individuals with limited mobility.

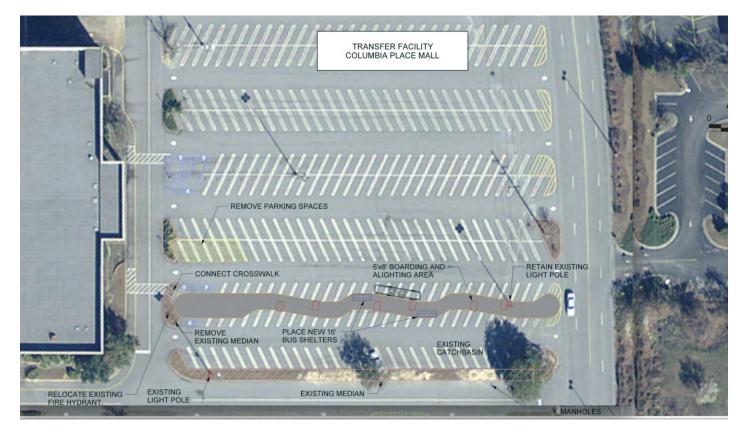
As part of the Richland Renaissance Plan, Richland County acquired a section of Columbia Place Mall. As a result, The COMET now has an opportunity to negotiate an agreement with a public entity that could allow for the construction of a unified transfer facility inside of the CPM property. Based on preliminary conversations with county officials, the CMRTA is proposing the construction of a transfer facility on the vicinity of Parking Island Five (old Dillar's department store). Image 3 illustrates a quick sketch of the proposed facility. At minimum, this facility would contain four to six bus bays on a sawtooth configuration and space for shelters, benches, and other amenities.

Image 3. Draft sketch of the proposed Northeast Connection Protection Zone. Sketch was made for illustration purposes only, it is not a final design.

The COMET recognizes the parking lot of the CPM was not constructed for use with heavy duty transit buses. Indeed, this reason was often cited for not wanting the bus to enter the property. The COMET is prepared to assist Richland County with upgrading a path for buses to use with higher grade asphalt. The COMET also understands this agency would be responsible for the construction and maintenance of the facility. This agency requires only the appropriate easement documents from Richland County.
